VISIT TO PLYMOUTH BREAKWATER, 20 MAY 2023

by Ken Trethewey

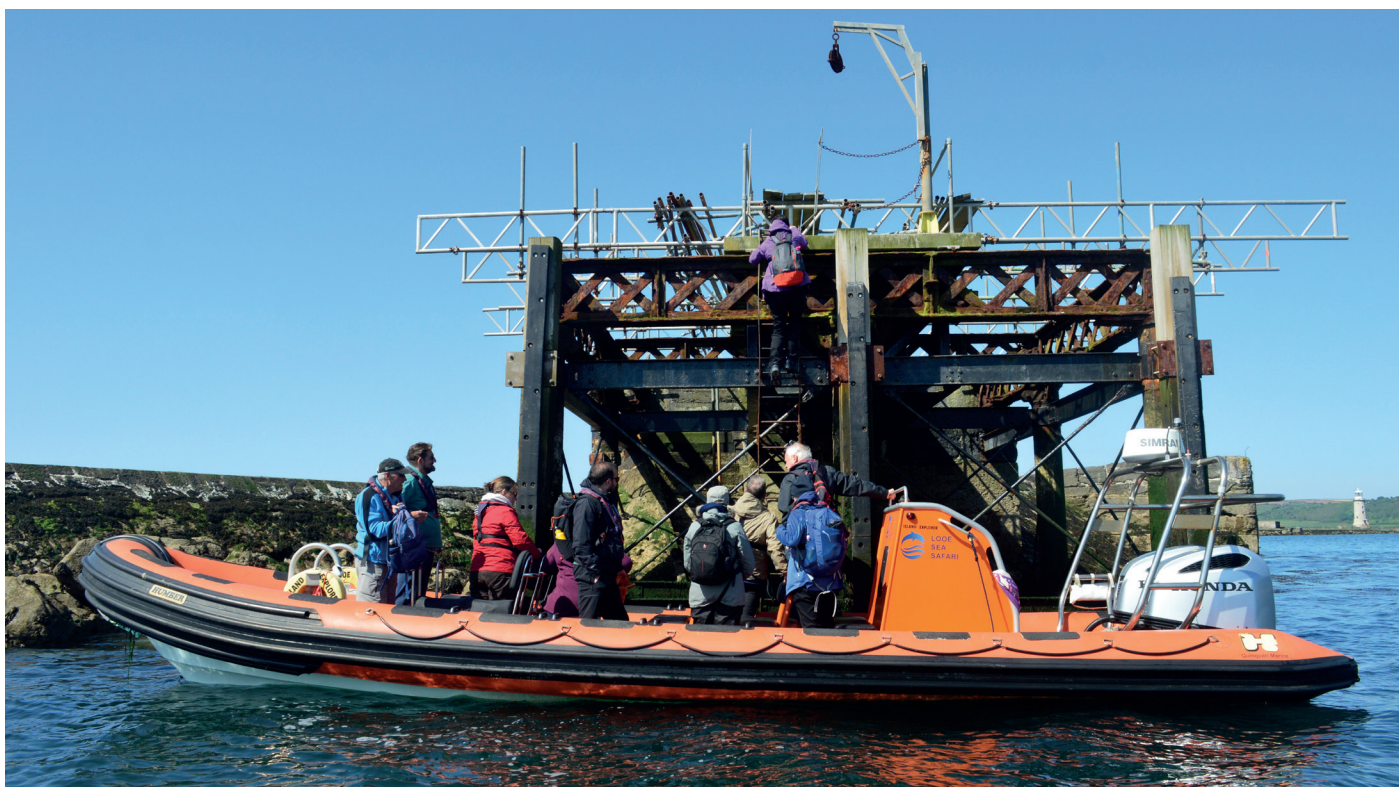
*Above: Landing is tricky. A vertical ladder with metal rungs must be climbed and then scaffolding hazards negotiated.
Below: Once on the Breakwater, the lighthouse is 690 m distant along the western side.*

Access onto the Breakwater was difficult, by means of a vertical metal ladder that some of us were unfortunately unable to climb. Once at the top, the way forward was hazardous because of an array of scaffolding poles and planks, but this did not deter those who made it onto this amazing structure. The Breakwater was constructed between 1812 and 1843 and is made of an estimated four million tons of large stone blocks. The structure is 1575 m long, and we landed in the centre of it, at the half-way distance, close to the fort (see later pages) that is situated 30 metres behind the great block structure.

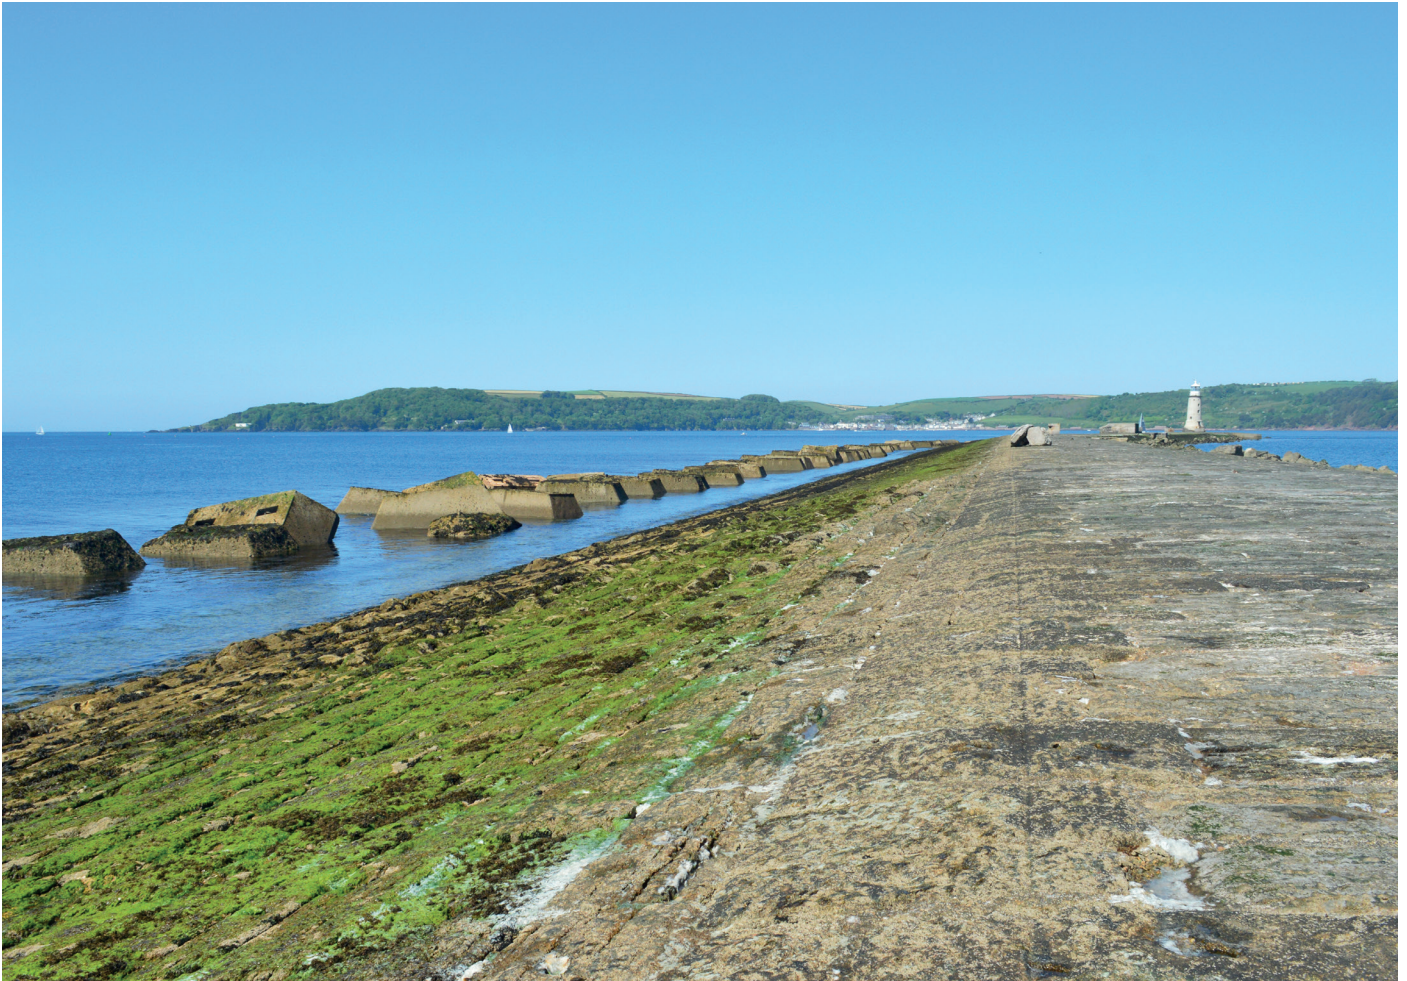
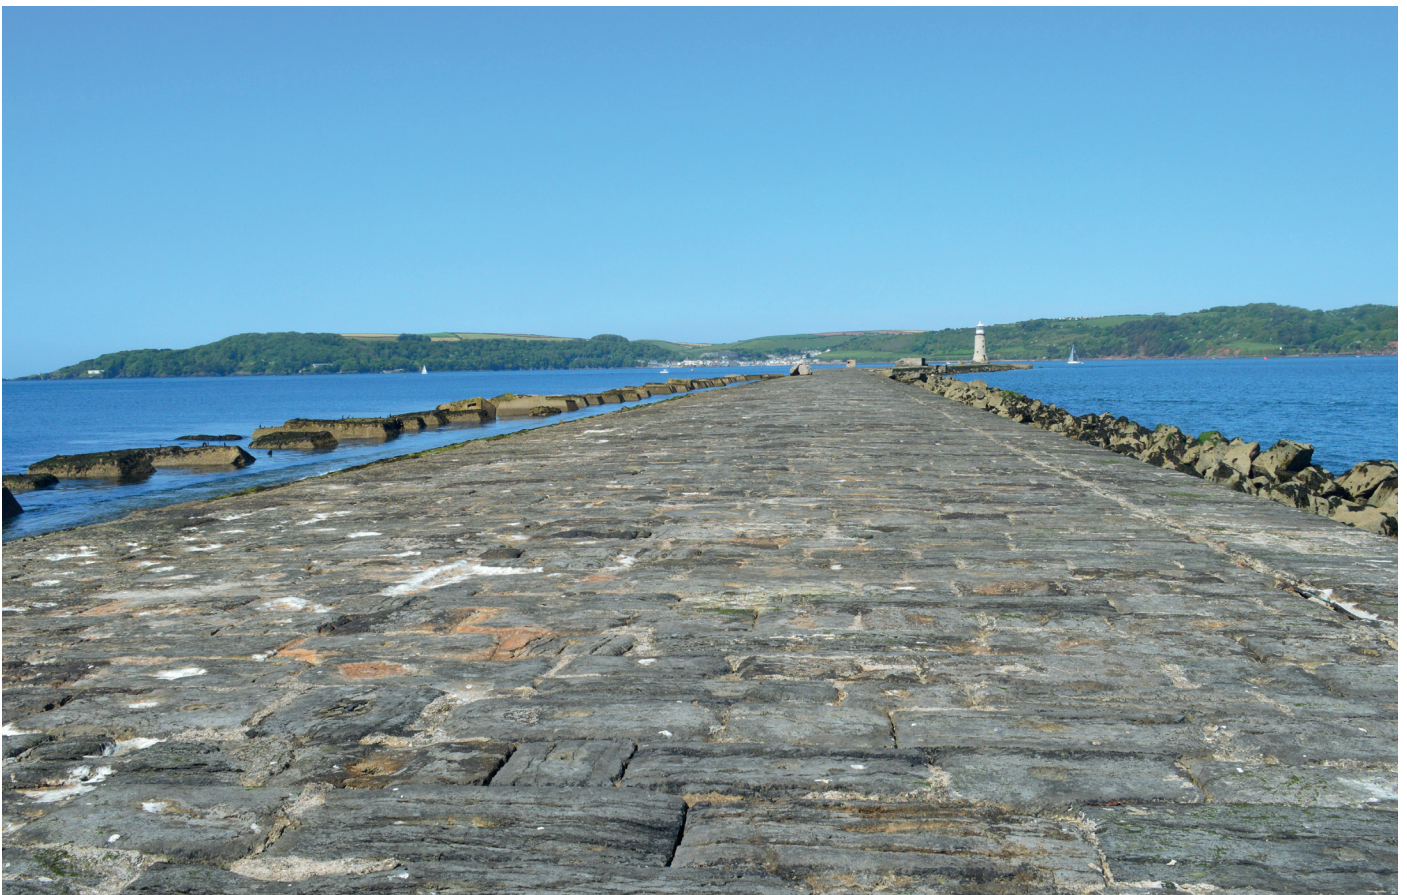
Above and Below: The Breakwater is surprisingly wide, its edges gently sloped to minimize damaging impact by the sea, whilst extracting the energy out of the waves. An additional line of huge blocks were later added along the south-facing seaward edge, dropped in place using specially designed cradles to lift and drop such heavy stones.

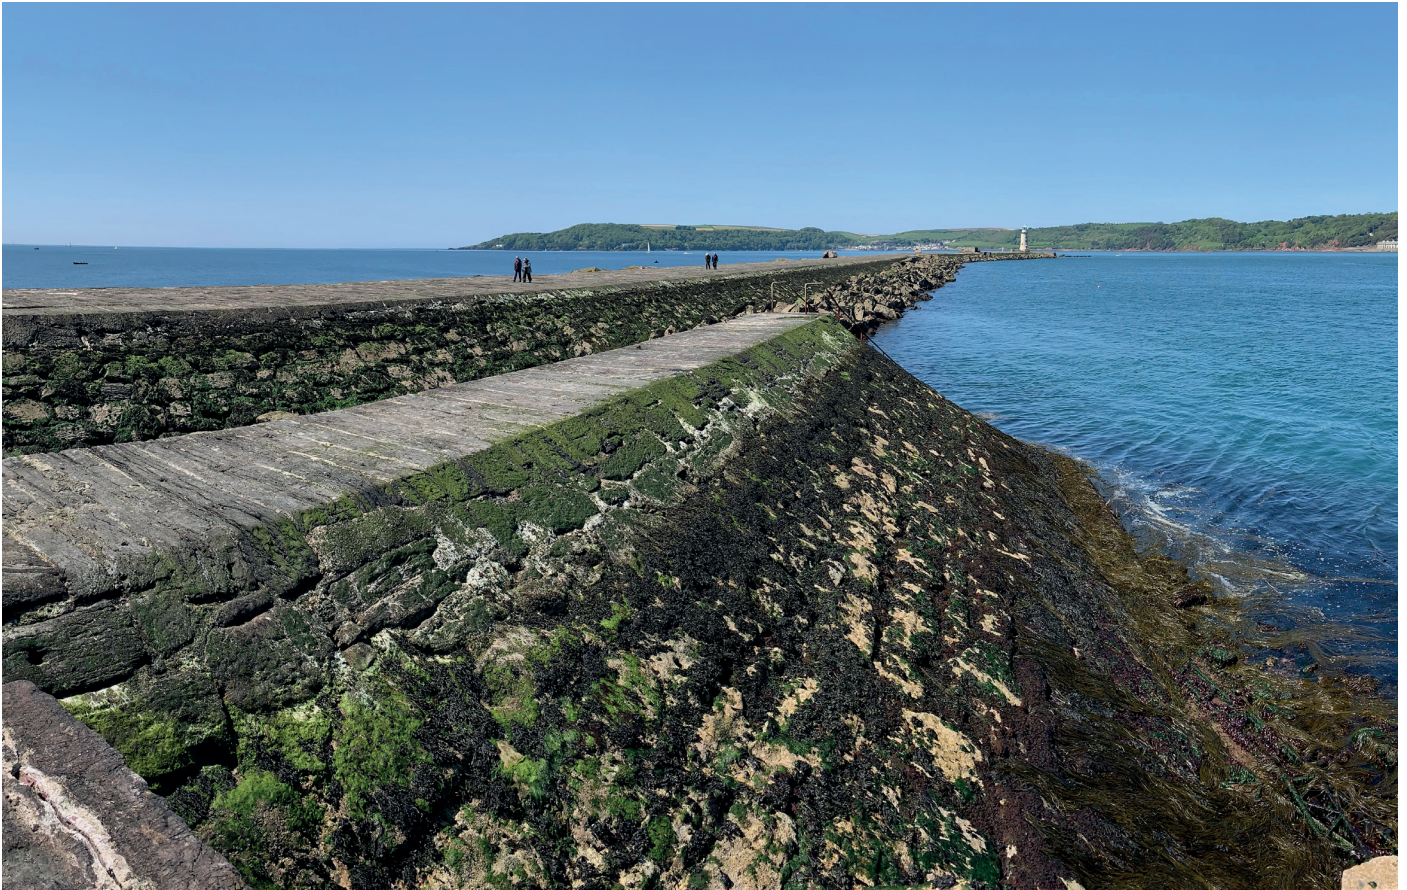
*Above: The central part of the Breakwater has extra reinforcement that once formed a harbour for supply of stone.
Below: A typical view of the top surface of the Breakwater shows the interlocking stones.*

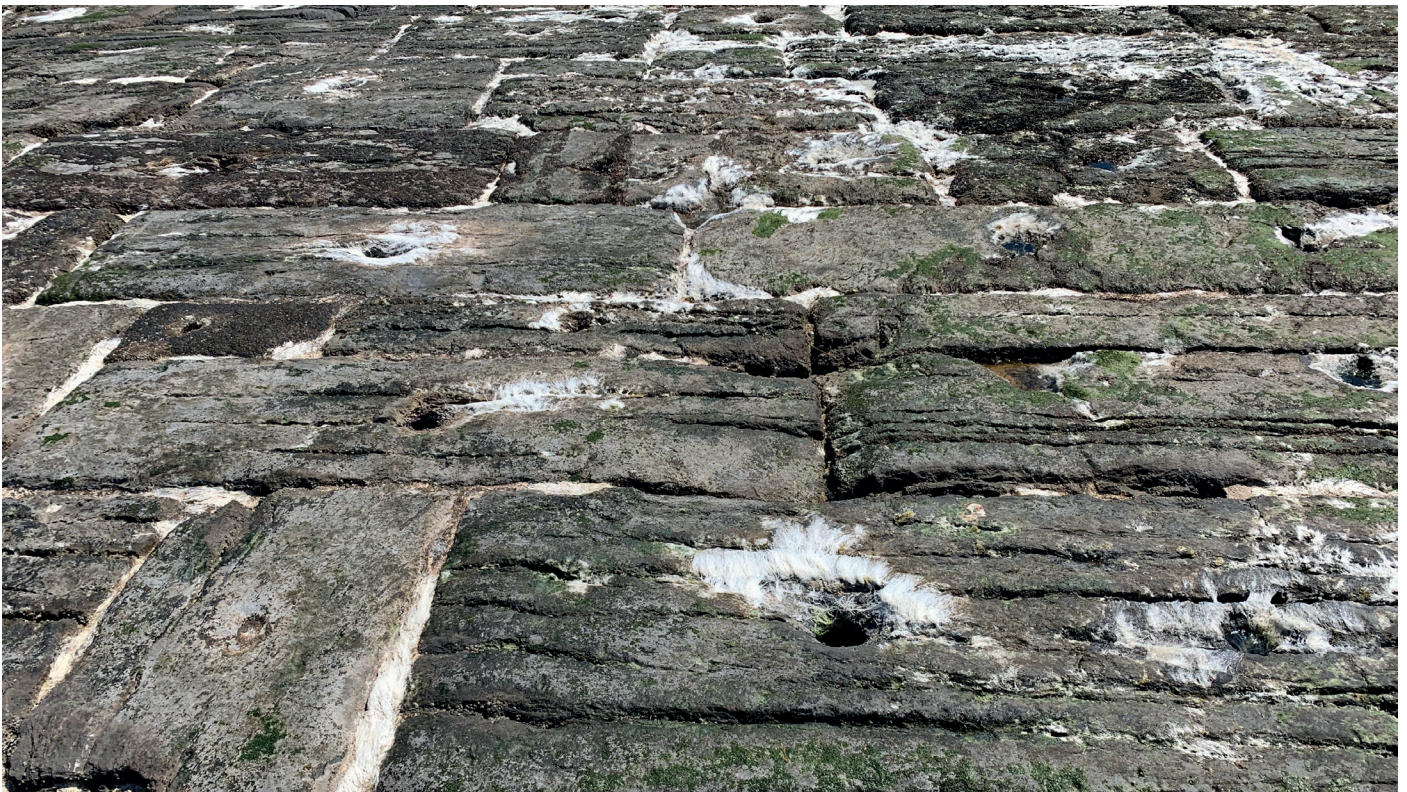
The surface of the Breakwater was significantly pock-marked, both by erosion and man-made holes, and made slippery by the usual marine growths that are found on water-soaked surfaces. Some care was necessary as we made our way across this uneven slippery surface towards the lighthouse at the far west end of the Breakwater.

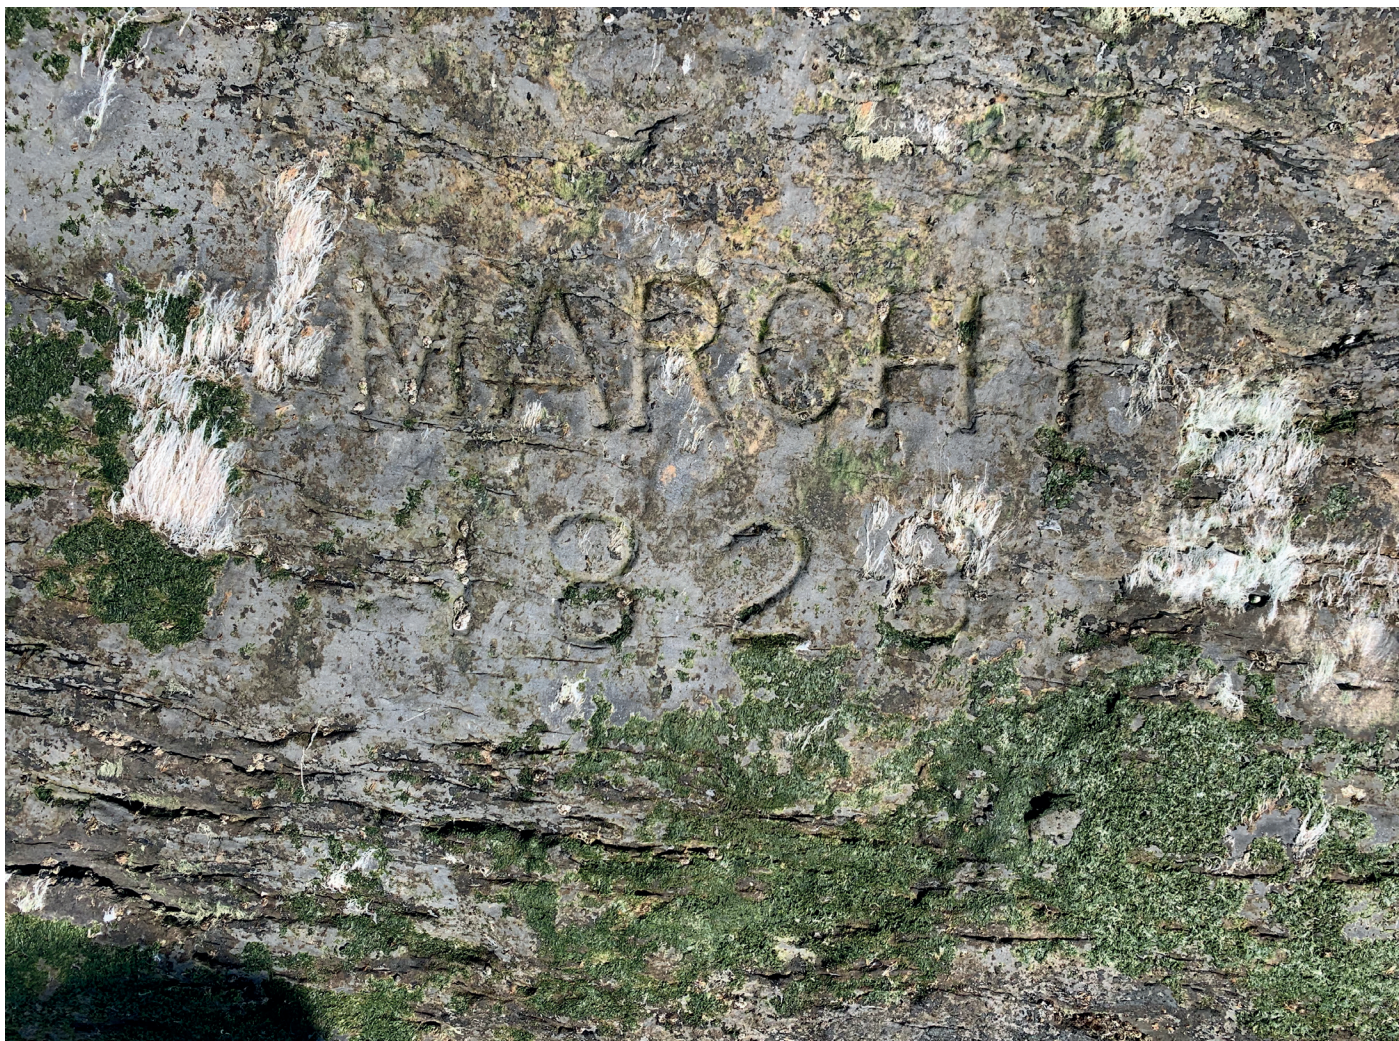
Above: One stone has March 1828 engraved into it, laid during the course of the build.

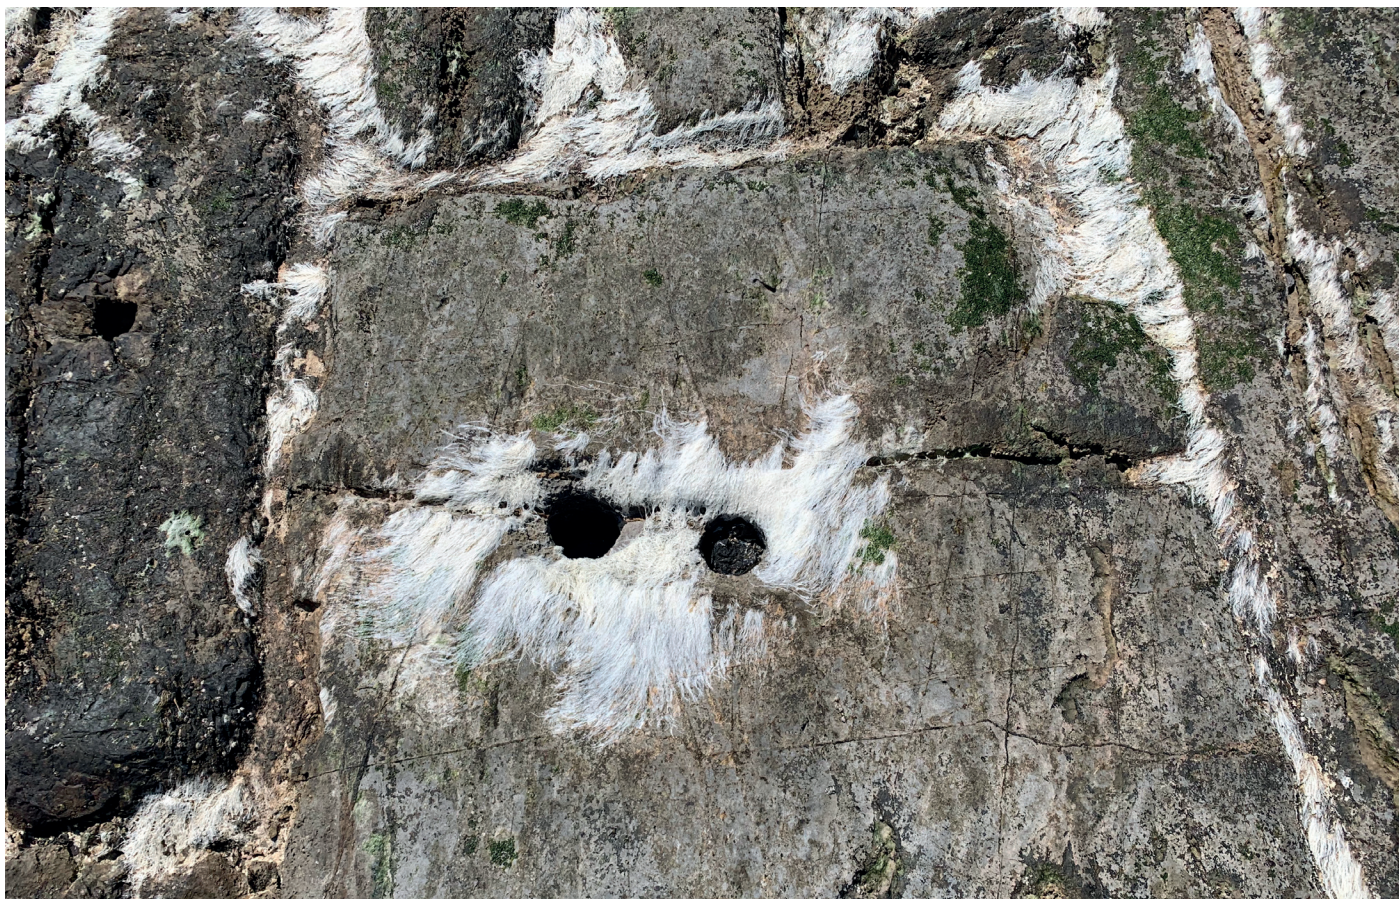
Below: Many of the stones have holes used to facilitate placement. White whiskers of a marine growth are everywhere.

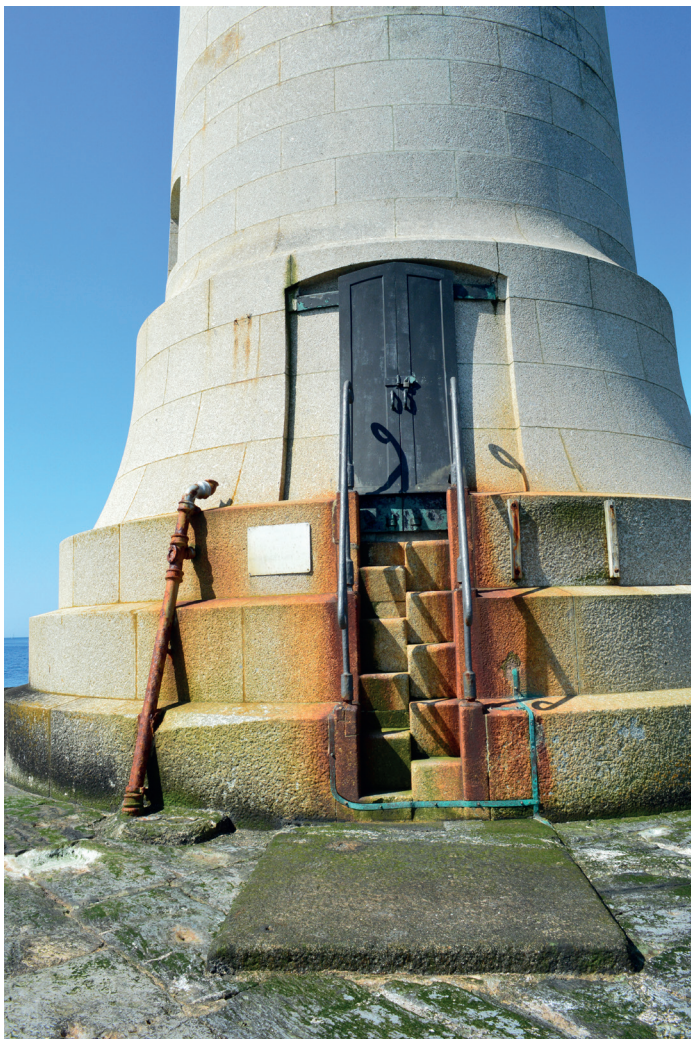
Below: The entrance as it is in 2023. The two gunmetal doors are very heavy and slide in horizontal tracks.

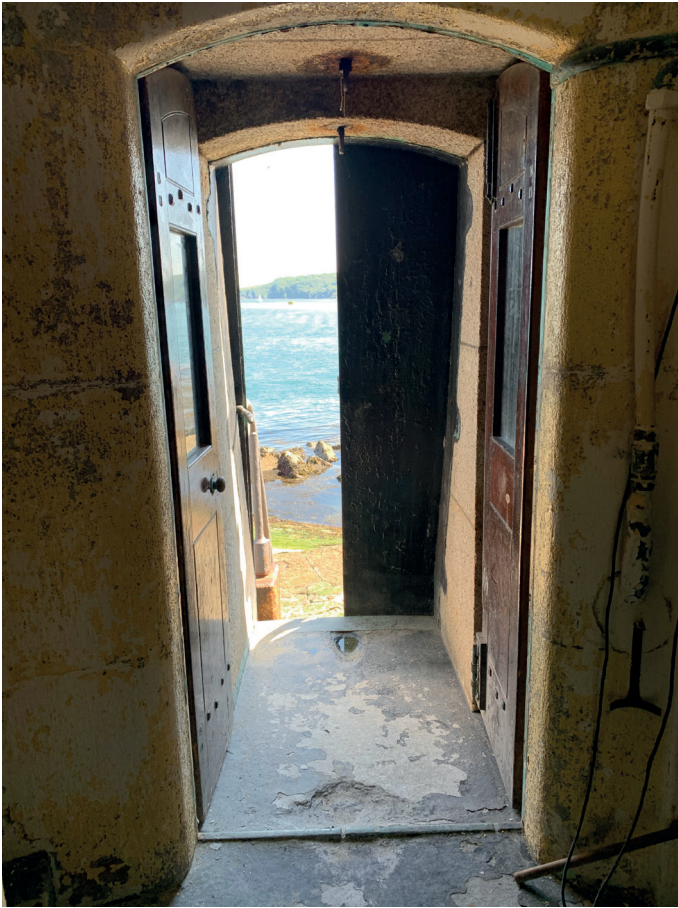
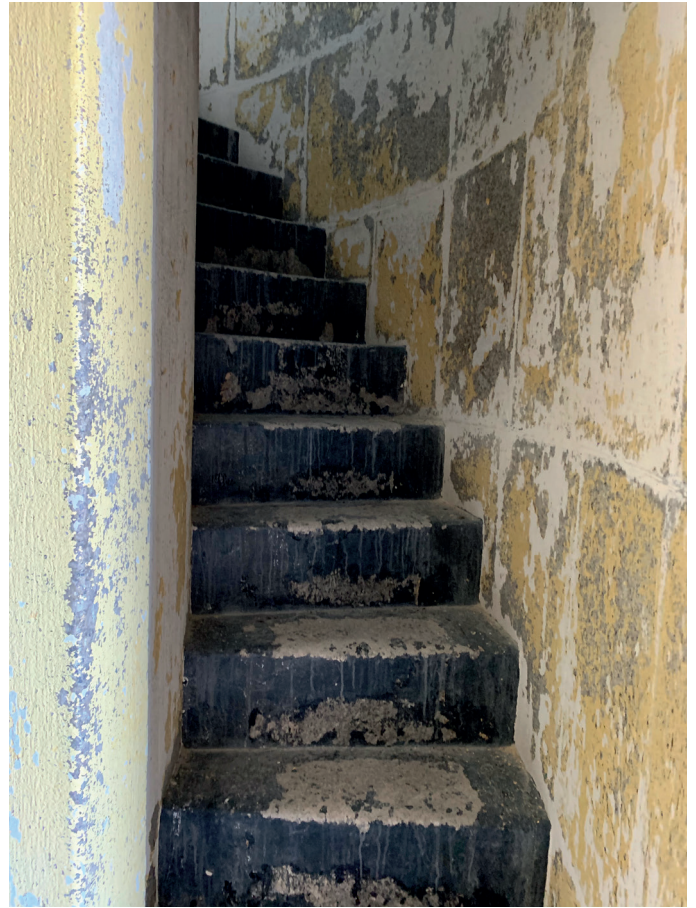
*Above: Level 1. The entrance door from the inside.
Below: The window-less oil store room, level 1.*

*Above: The staircase going up anti-clockwise.
Below: The manhole in the floor, is for the water tanks.*

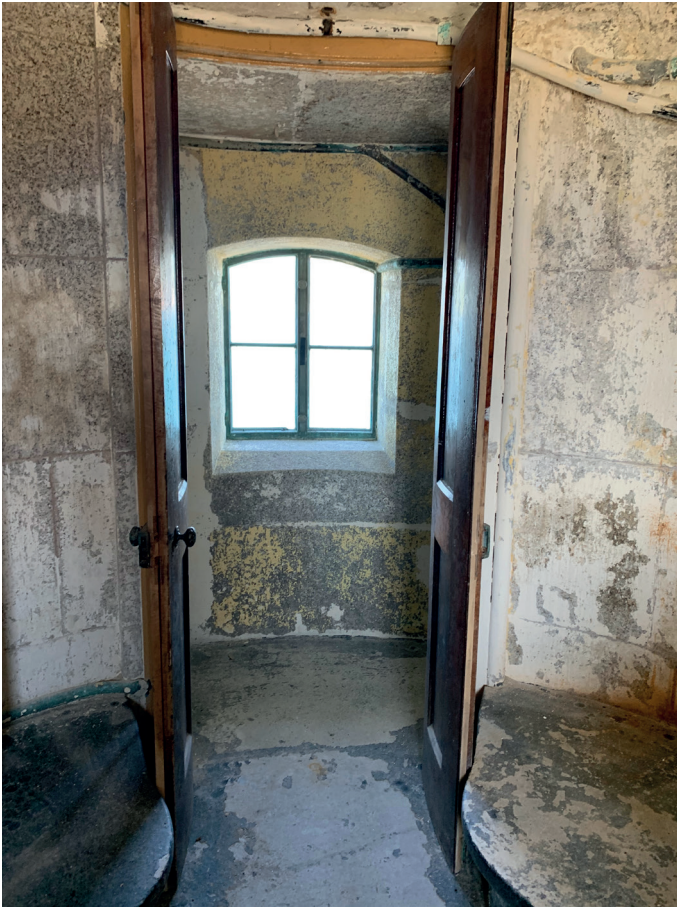
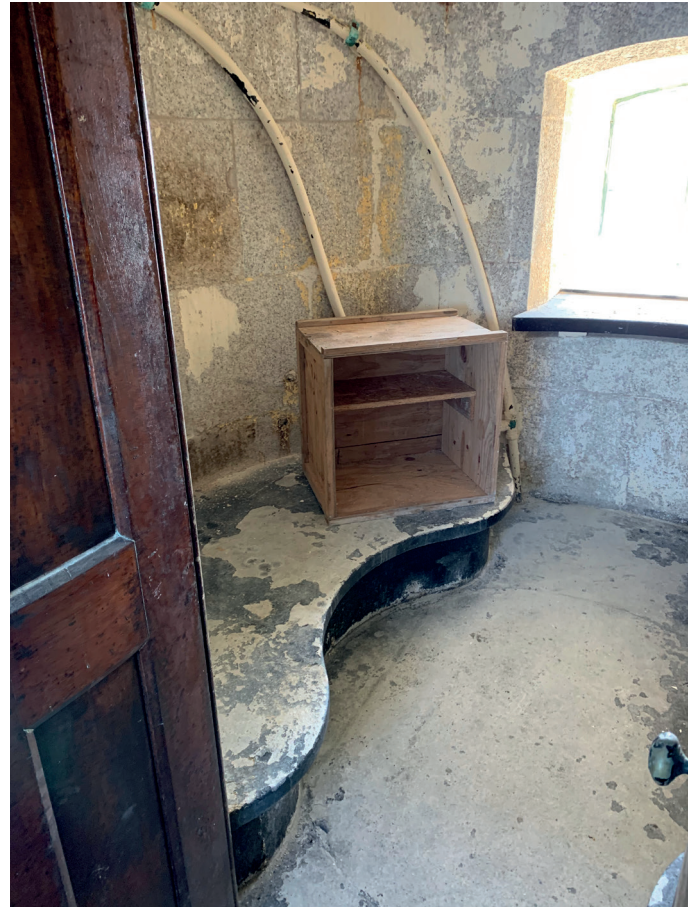
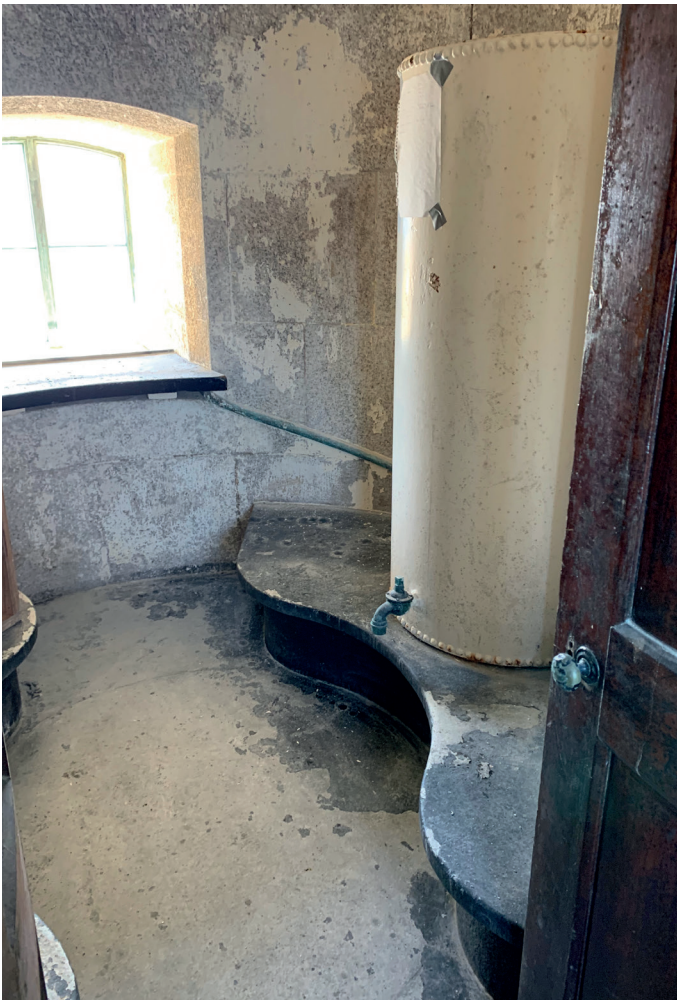
Level 2: This was originally called the oil store - two half-doors at the entrance because there is no room for a single door. The purpose of the unique, kidney-shaped plinths is curious, apart from elevating containers that need to be raised off the floor, as is the case with what looks like a water tank on the right, below.

So, with the right-hand door open wide enough for us to enter, we were inside a lobby where we found another door. This door seemed to be locked, for again I could not make it budge. I had no second key, and I thought our mission was doomed to end in failure. Fortunately, after some serious tugging, the door gave way and we were finally able to make our way inside. There were five levels of stone rooms, surmounted by a wrought iron lantern. On the first level, we found a basic room - once known as the water room - with the usual array of oddments that make sense only to those who work there. We also found a chemical toilet hidden behind a curtain hanging crudely from temporary fixings. Luckily, none of us needed to use it, although it was a close run thing! The staircase led upwards anti-clockwise on the right and ascending the stone stairs we found level two where there had been an oil store.

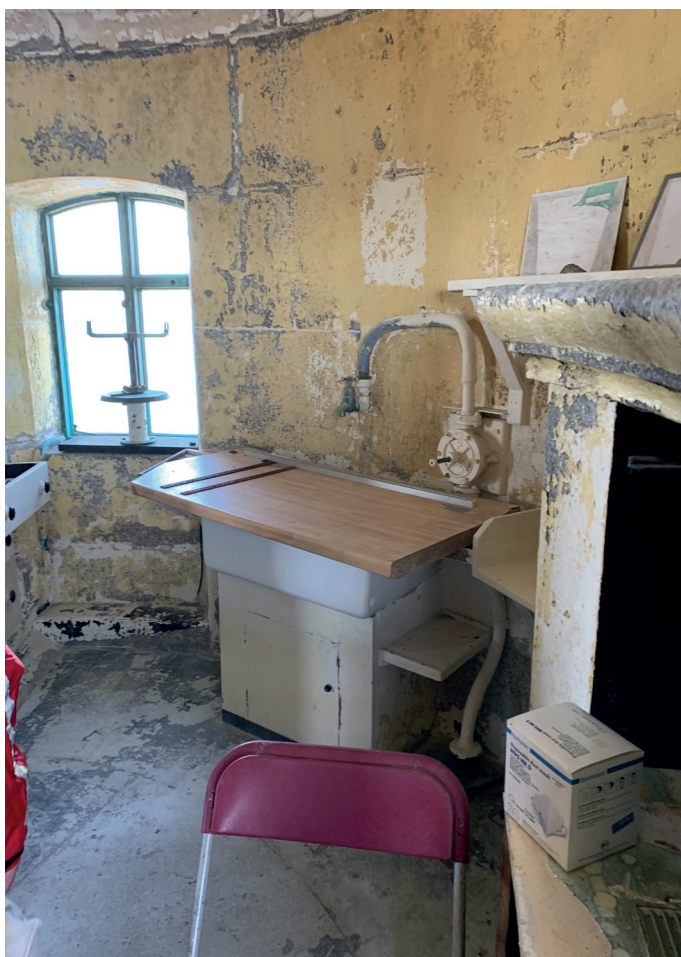
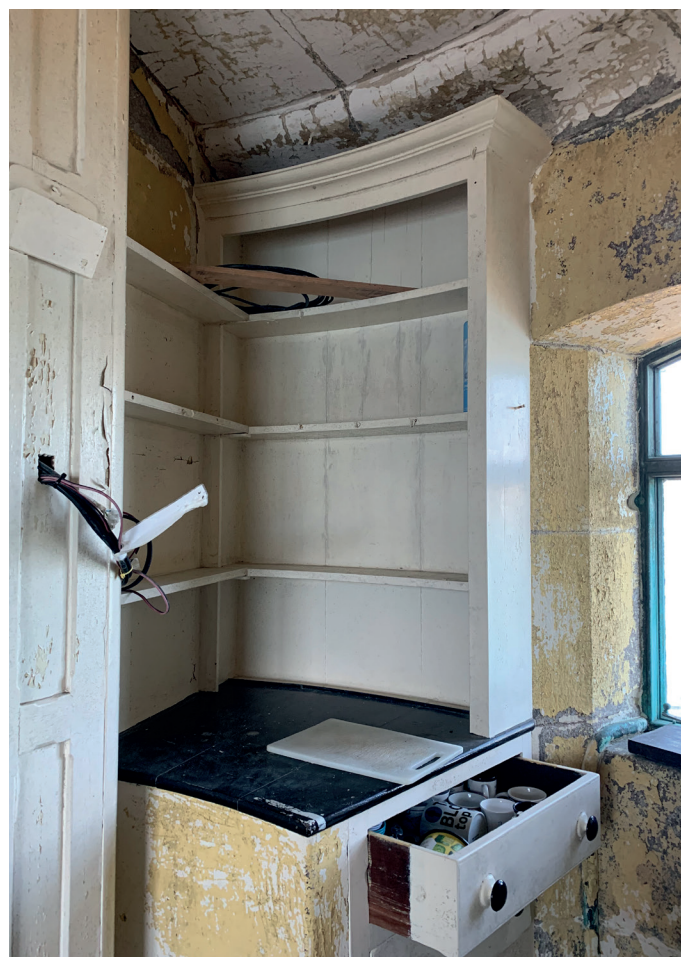
Level 3 - The living room

Above: A porcelain sink covered by a work surface. A close-up of the water supply, a lead pipe that could not be used today because of toxicity.

Above: A small work area and drawer filled with modern tea mugs. [Photo: Ann Dodkin.]

Below: Useful storage space is to be found beneath the stone staircase.

The living room (or kitchen, as it was often called) left us with just a fraction of the atmosphere it would have once had. Was there ever a dining table? Almost certainly. A comfy chair? Maybe not. There was a fireplace, where cooking was carried out, a sink, with its tap and pump that pulled water up from the tank below, through lead pipes that would be too toxic to use today. A drawer had been conveniently left open to show us where the tea mugs were to be found. A pity - a cuppa would have been nice! A cupboard contained modern items left by workmen. One point of interest is that the cupboard door is planar, whilst the entrance door is beautifully crafted in a curve to fit the curvature of the tower. No, it's not a figment of my camera lens.

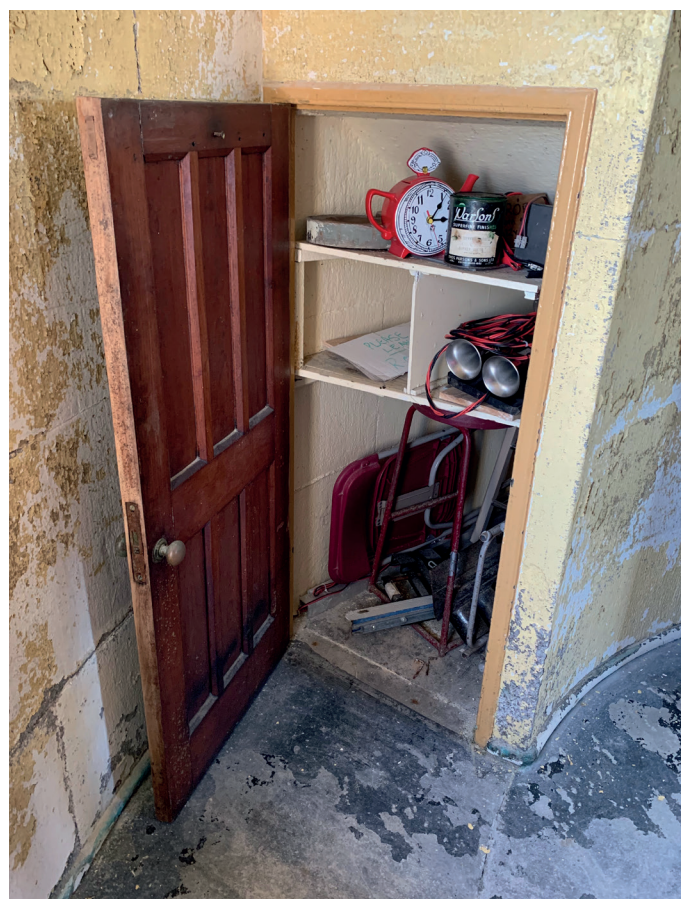
*Above: Level 4. In the bedroom the usual curved bunk beds are to be found. The Low light is also found here.
Below: This photo shows the position of the low (secondary) light relative to the bunks. [Photo: Ruth Drinkwater.]*

A low, secondary light has been shown from a window in the bedroom for most, if not all of the tower's existence. The light was a white, isophase, flashing type, meaning alternate white and dark every four seconds from a height of 12 m and visible for 10 miles through the narrow angle of 8° from 031° to 039° . This angle is intended to show the bearing for ships leaving port by sailing across Plymouth Sound.

According to Findlay's List of Lights (1900) it seems that the low light was installed in 1880 as a fixed white light to cover what was described as an open channel SW $\frac{1}{4}$ W to SW by W $\frac{1}{4}$ W (phew!) Perhaps even then the Sound was starting to build up silt deposited from Plymouth's major rivers, making the exit across the Sound more difficult than it might have been. However, an earlier edition of 1862 also lists a low light but with no further details.

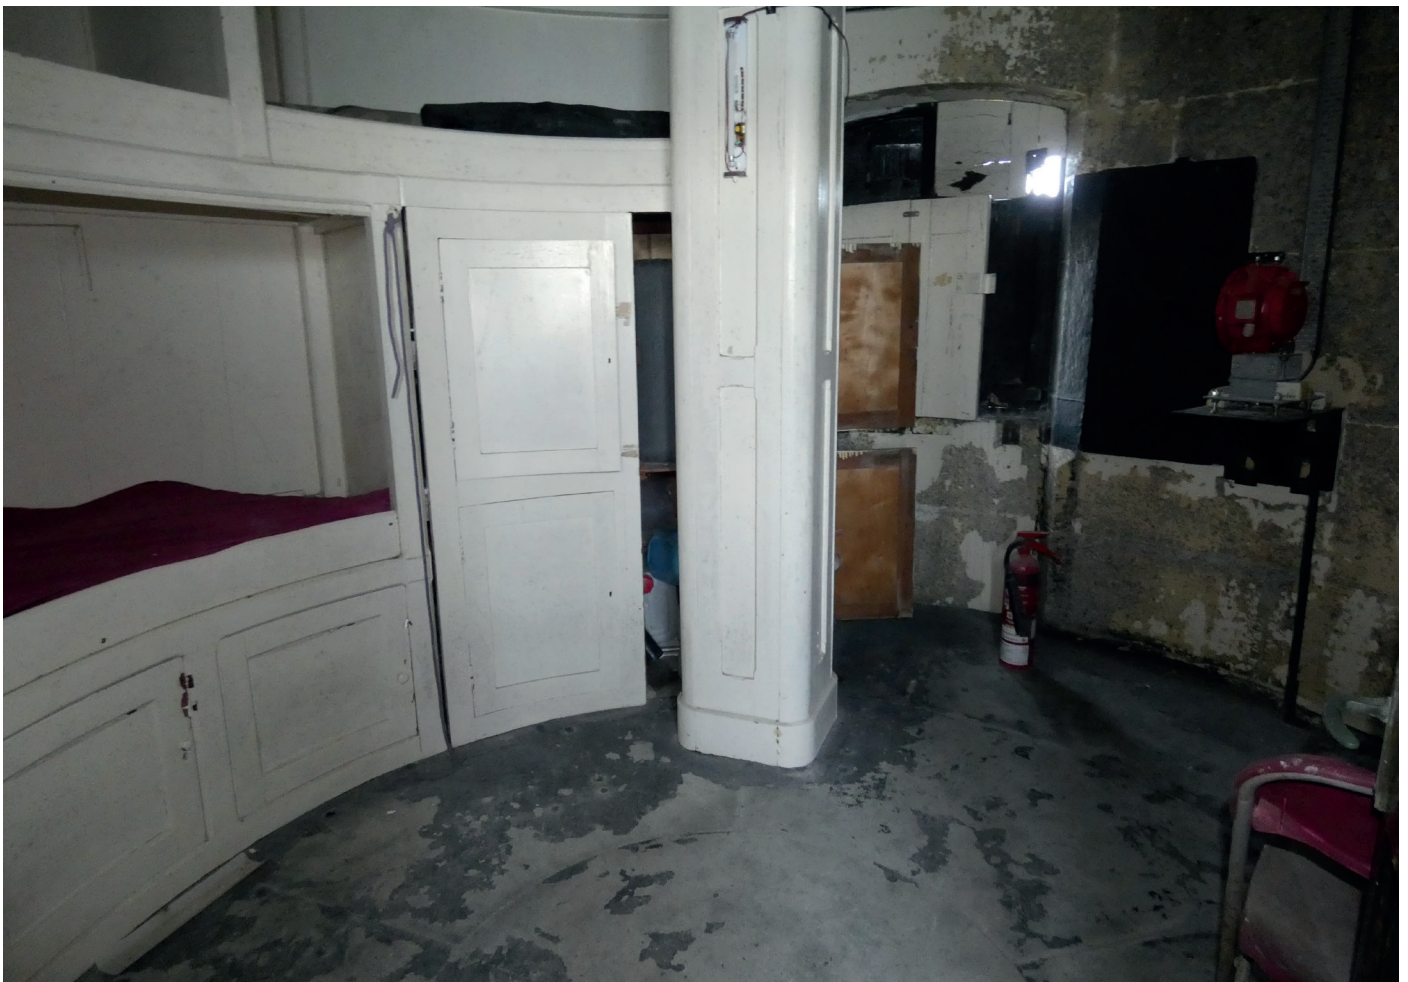
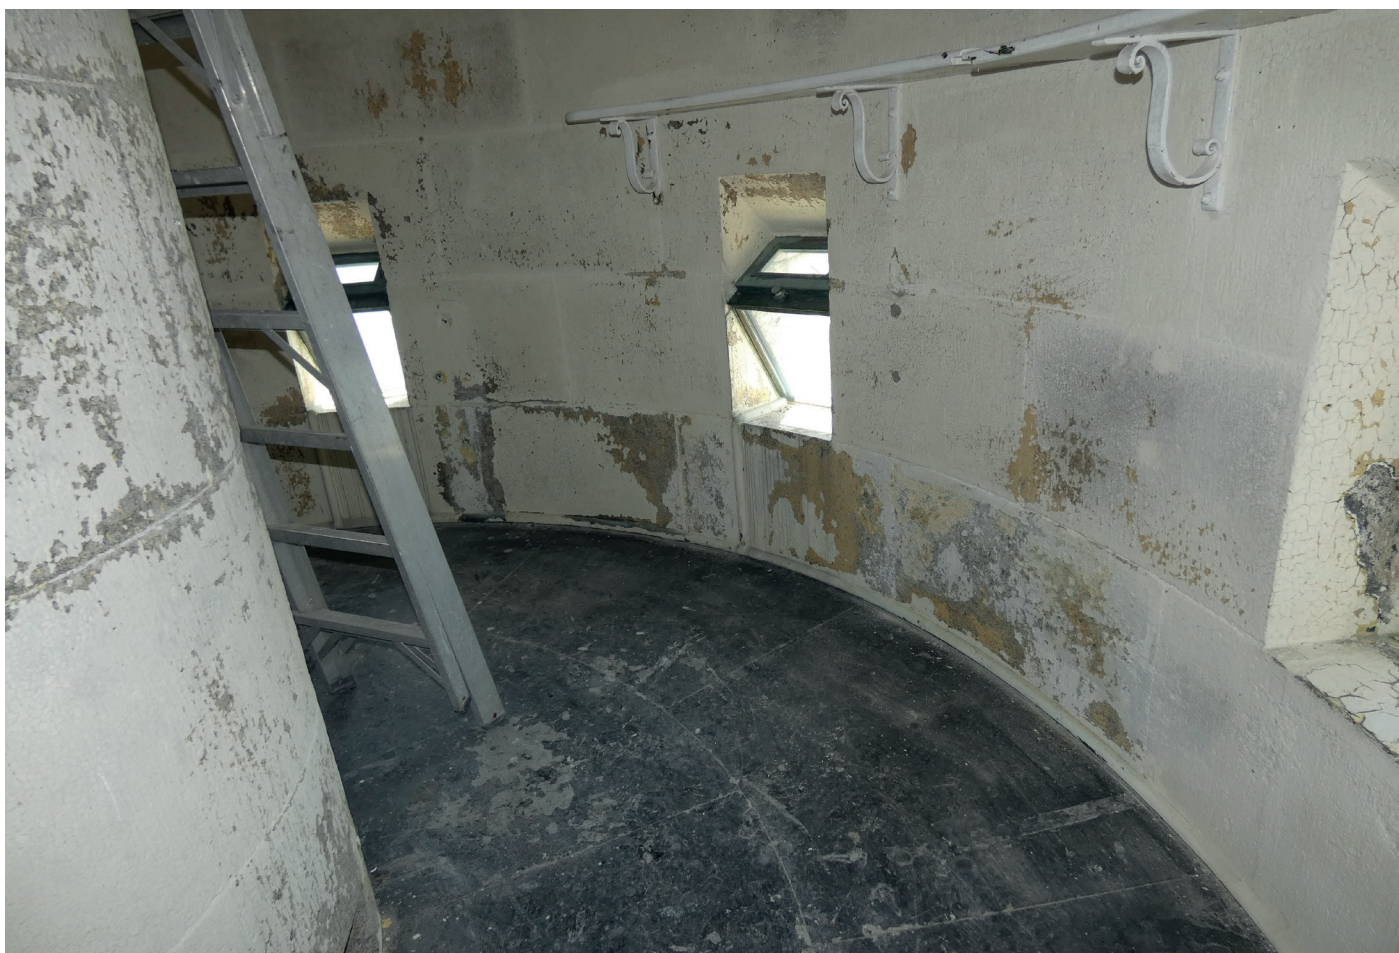
Above: Level 5. It seems (see Appendix) that the service room was a last minute addition to the design. We note the smaller windows that circle the structure. [Photo: Ruth Drinkwater.] Below: A unique, so-far unexplained feature.

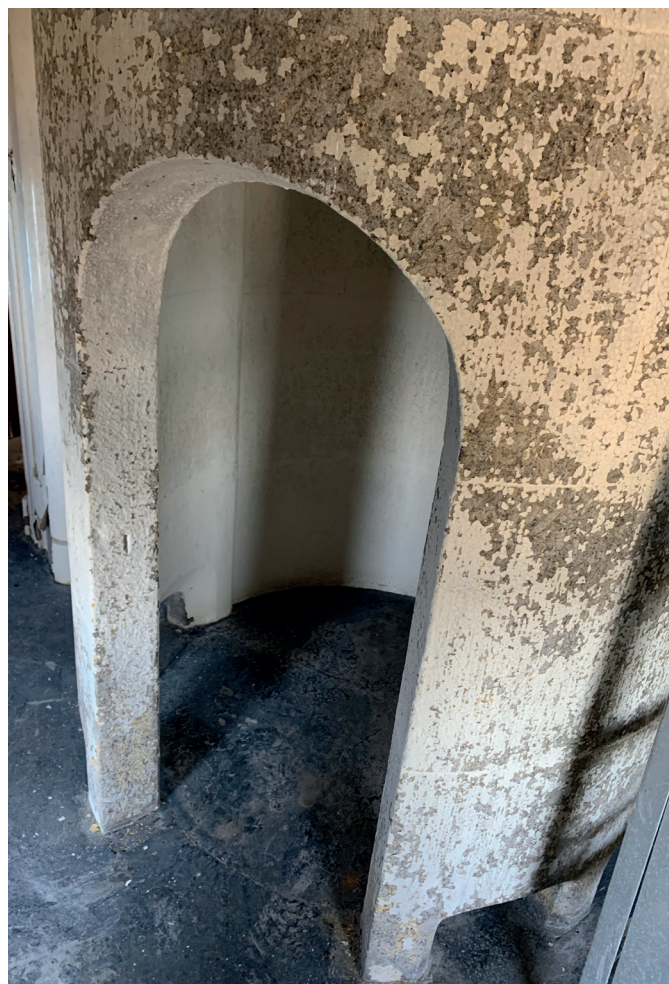
*Above: The smaller windows of the service room are of two angled panes set in gunmetal. [Photo: Ruth Drinkwater.]
Below: The stairs leading down from the service room to the bedroom. [Photo: Ruth Drinkwater.]*

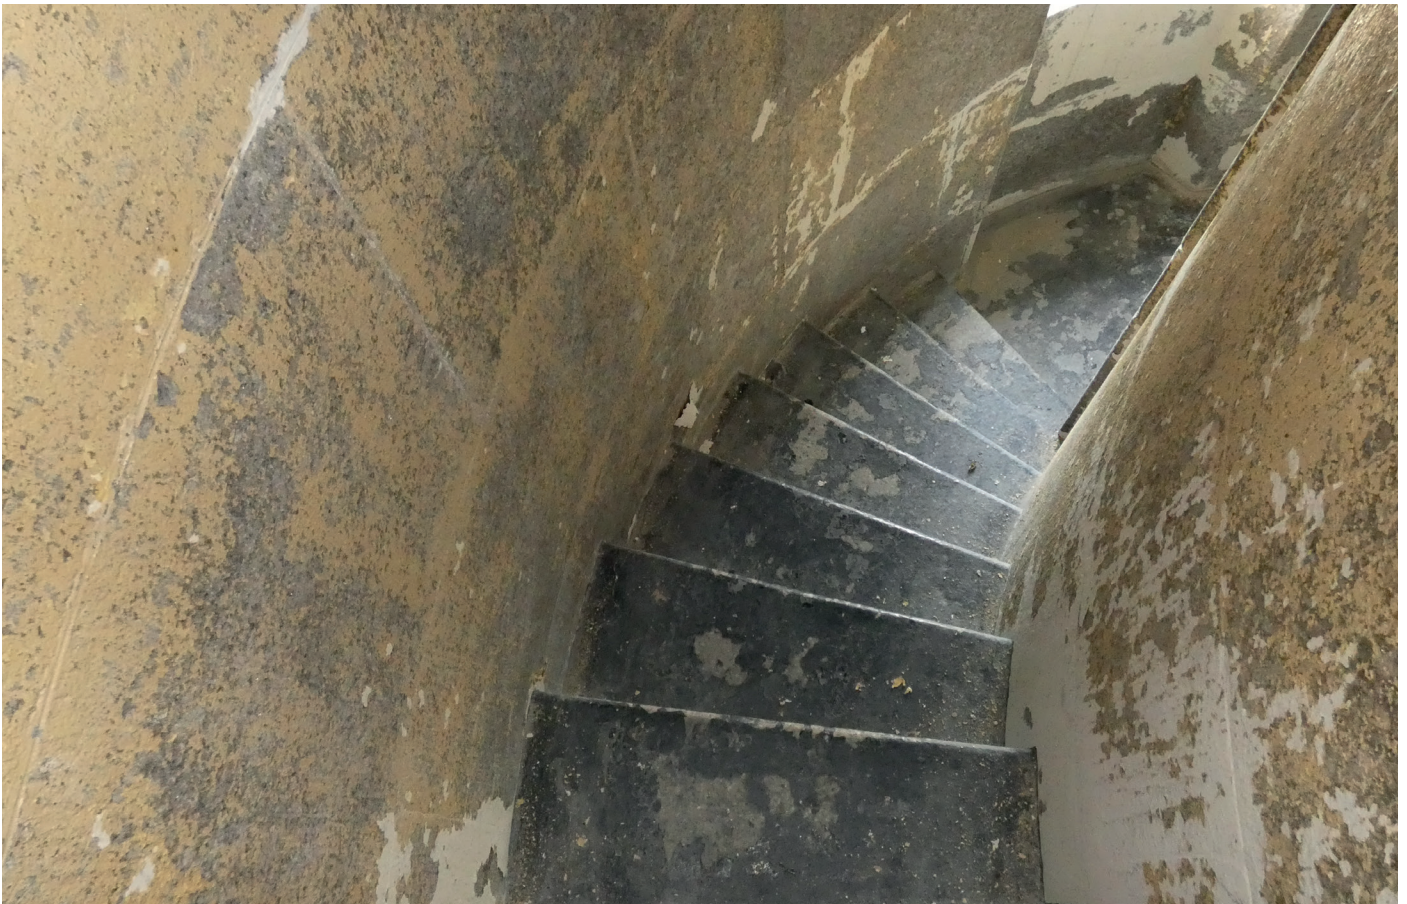
*Above: The steps leading down from the lantern room to the service room. The pedestal of the optic is on the left.
Below: Ventilators in the wall of the cast iron lantern.*
