VISIT TO PLYMOUTH BREAKWATER, 20 MAY 2023

by Ken Trethewey

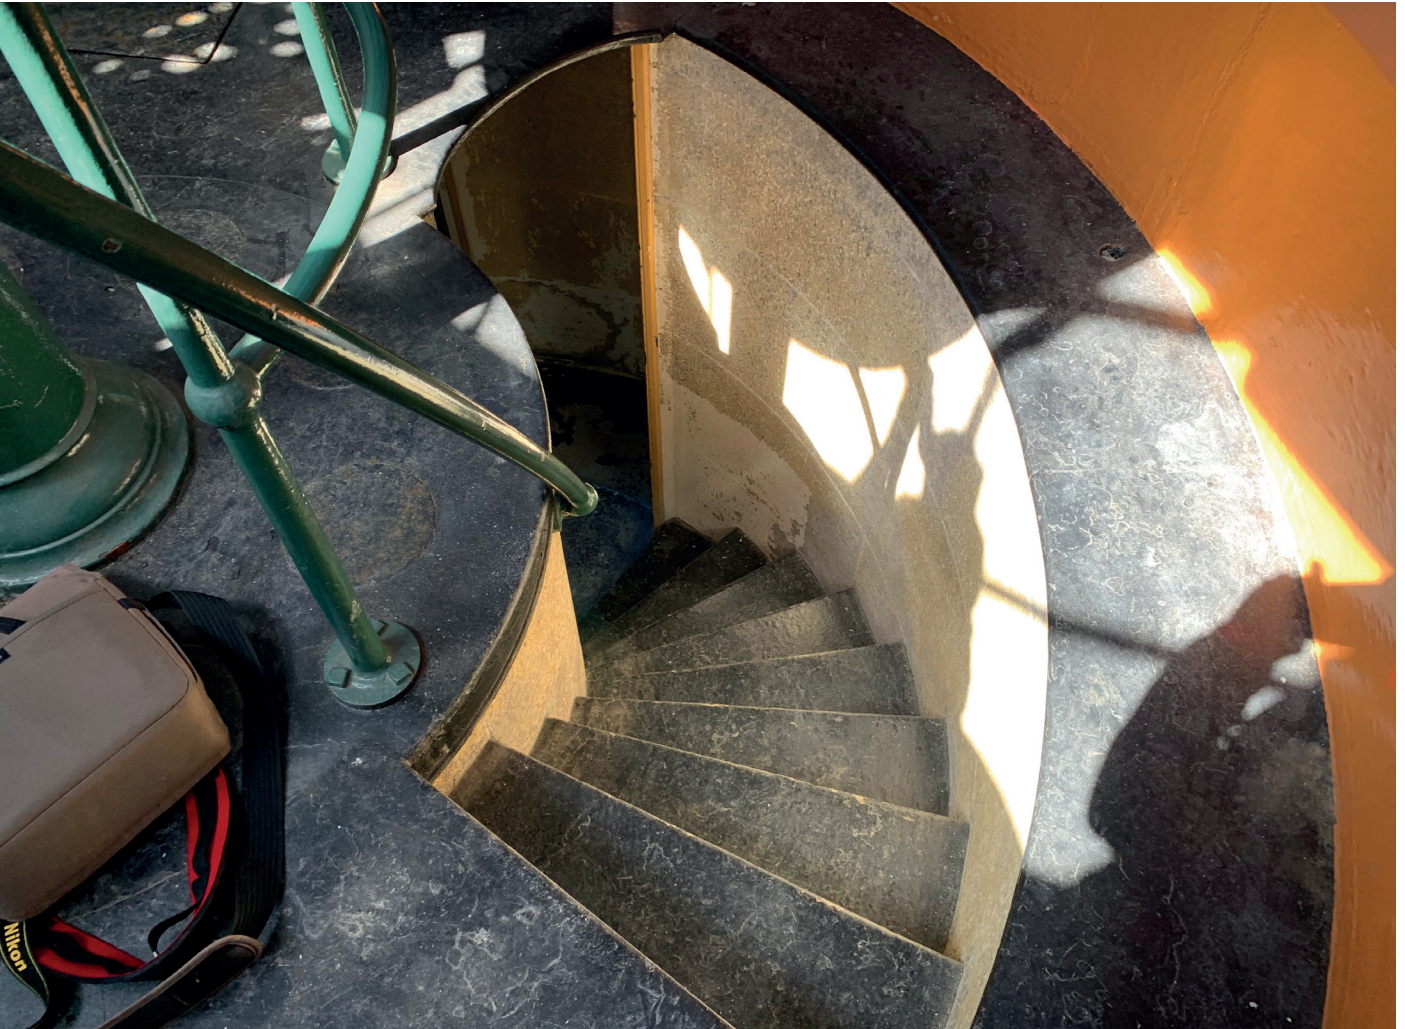
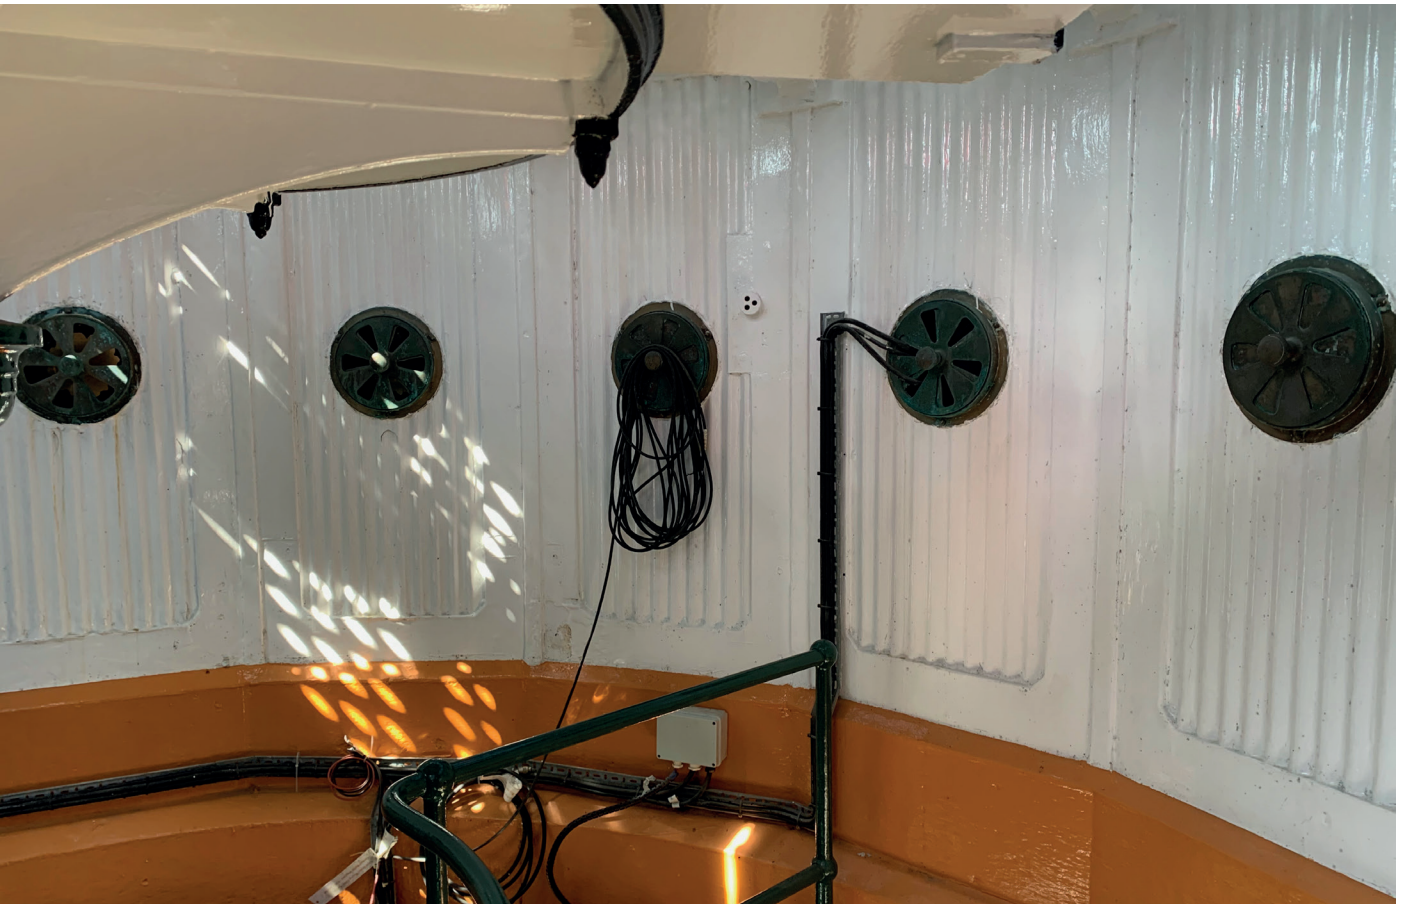
*Above: The steps leading down from the lantern room to the service room. The pedestal of the optic is on the left.
Below: Ventilators in the wall of the cast iron lantern.*

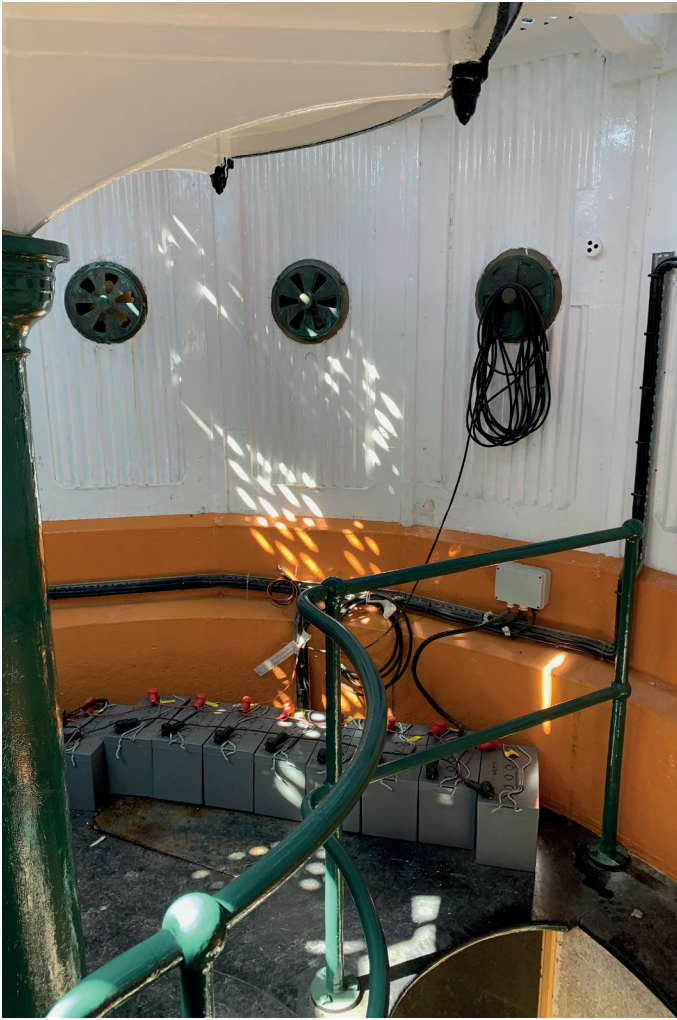
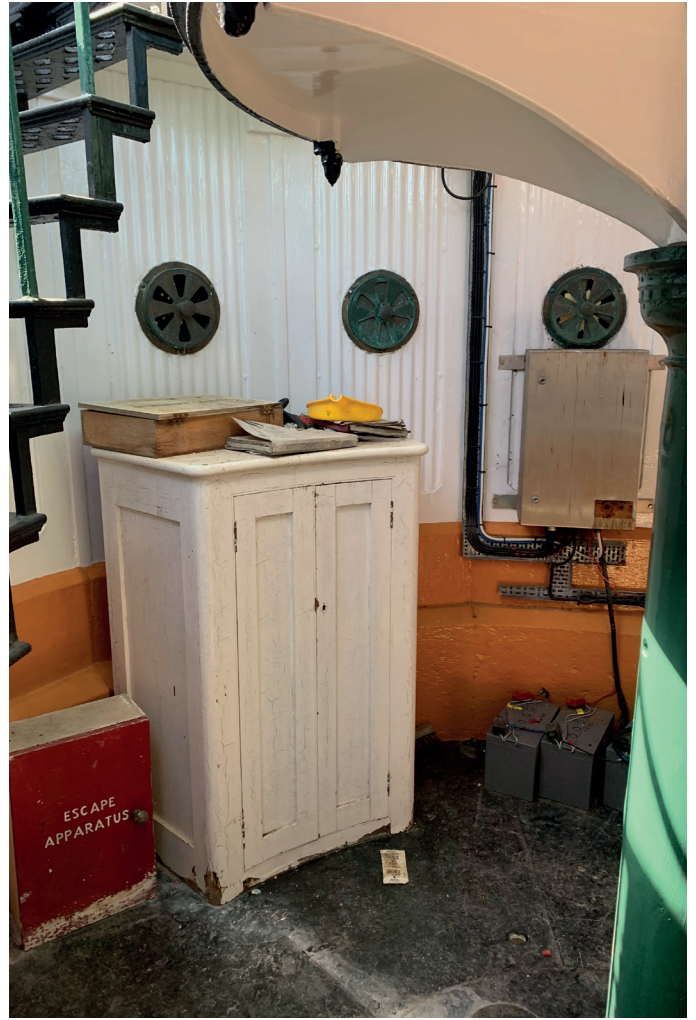
Above: The lower lantern area contains batteries to supply the light in emergency. Air vents around the inside wall are seen around the white-painted cast-iron lower part of the lantern.

Below: The magnificent cast-iron pedestal on which the beautiful optic is mounted. [Photo: Ruth Drinkwater.]

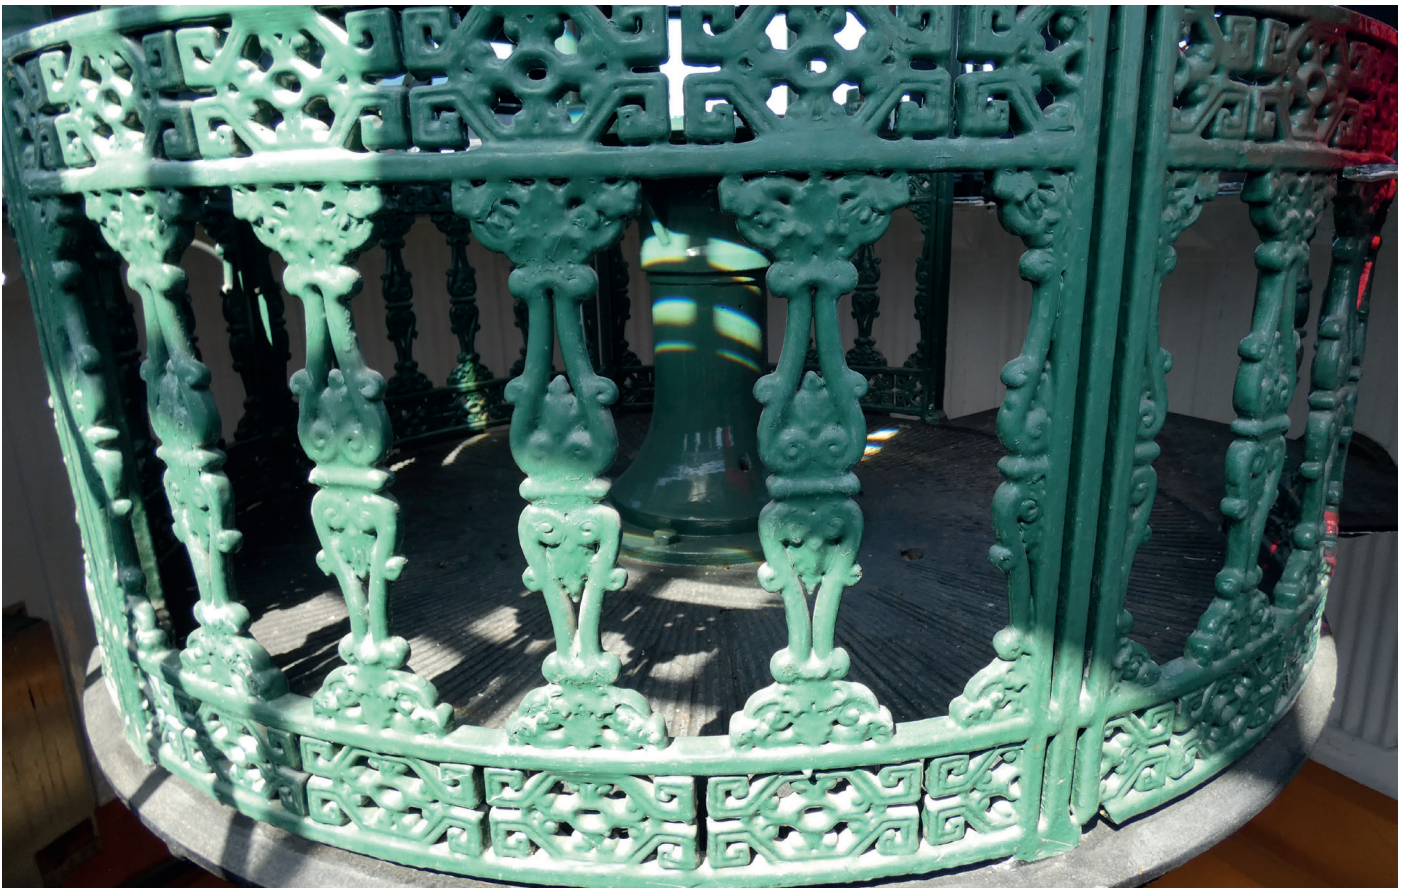
*Above: The original pedestal remains in place inside the optic. A cable provides the electricity for the lamp.
Below: The landward side of the optic has a cut-out section to give access to the light source. We note that the flue that would have carried away the gases - products of combustion of earlier paraffin lights - is also still present, leading up to its joint with the roof.*

It was a joy to finally reach the cast iron lantern on level six where we found a beautiful beehive optic with its red sectors, almost dominating the space in the bright sunlight. The main light currently flashes once every ten seconds, white with a red sector to the north-east; the subsidiary white light has an isophase characteristic, two seconds on, two seconds off. The optic itself was in beautiful condition, and in the centre of it were a number of small halogen bulbs on an auto-changer which would rotate bulbs in a vertical plane if one failed. The great mass of glass was lifted high up on a substantial platform, so as to send its light out through the square lantern panes that were above head height.

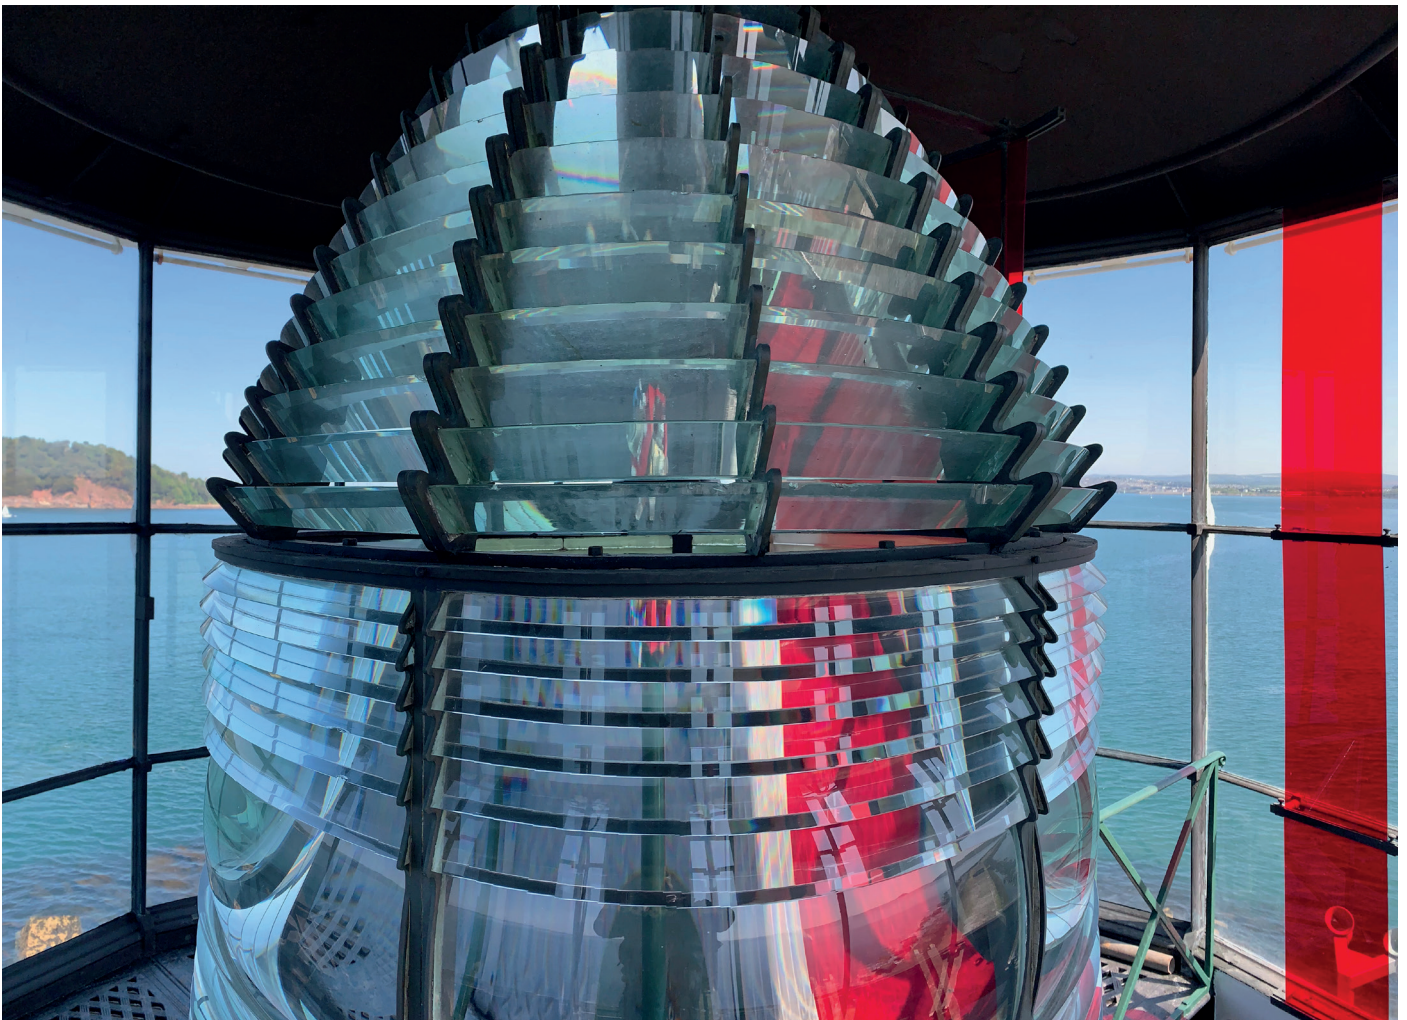
Above: The optic - known as a 'beehive' - is complete from this angle, but has a cut-out section on the reverse side that enables access for maintenance and visitors like me to look at the light inside.

Below: In this case, there are a number of small halogen lamps that can be rotated into position if one should fail.

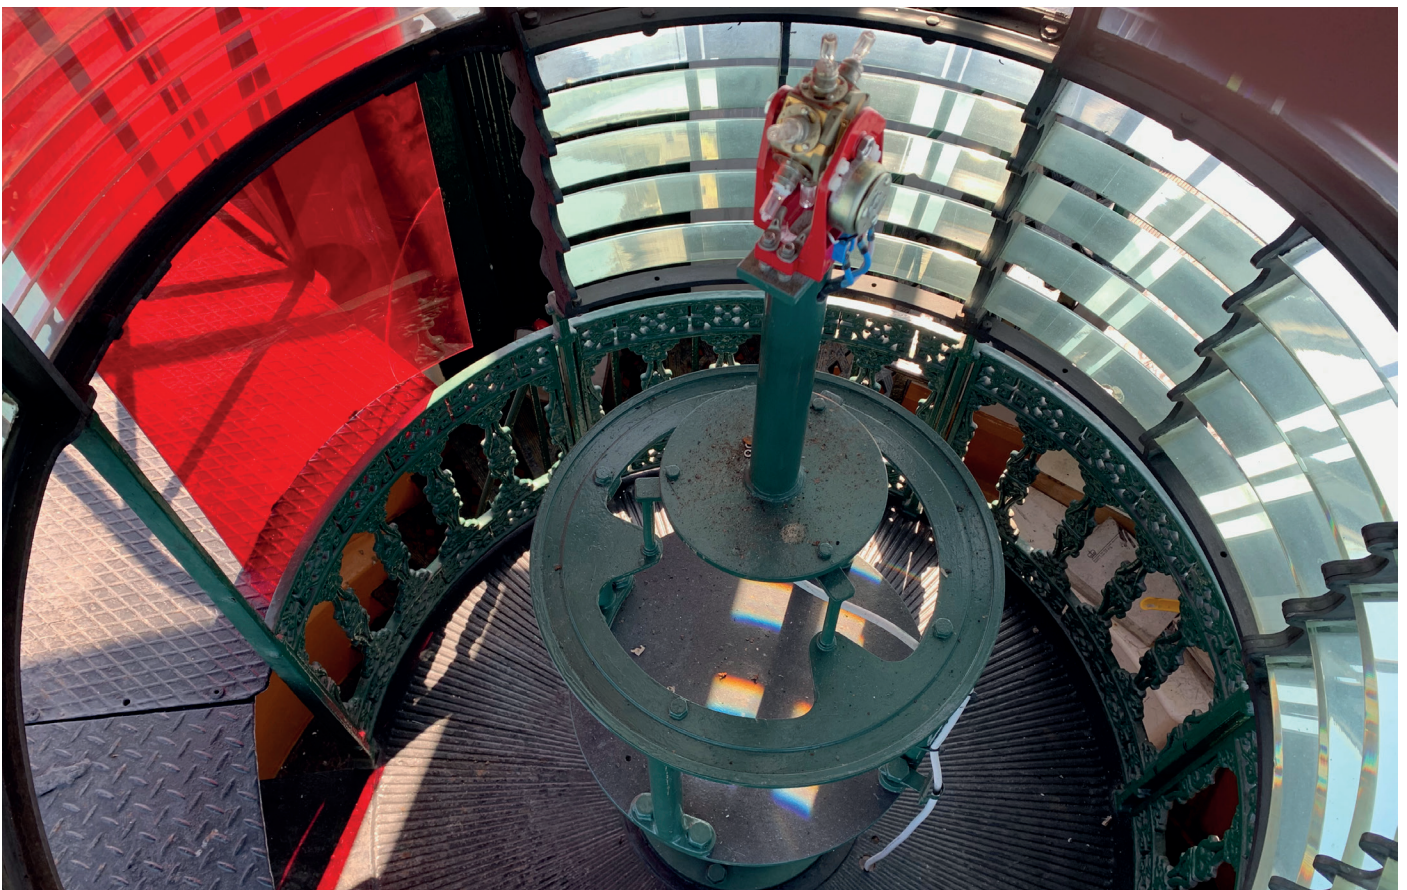
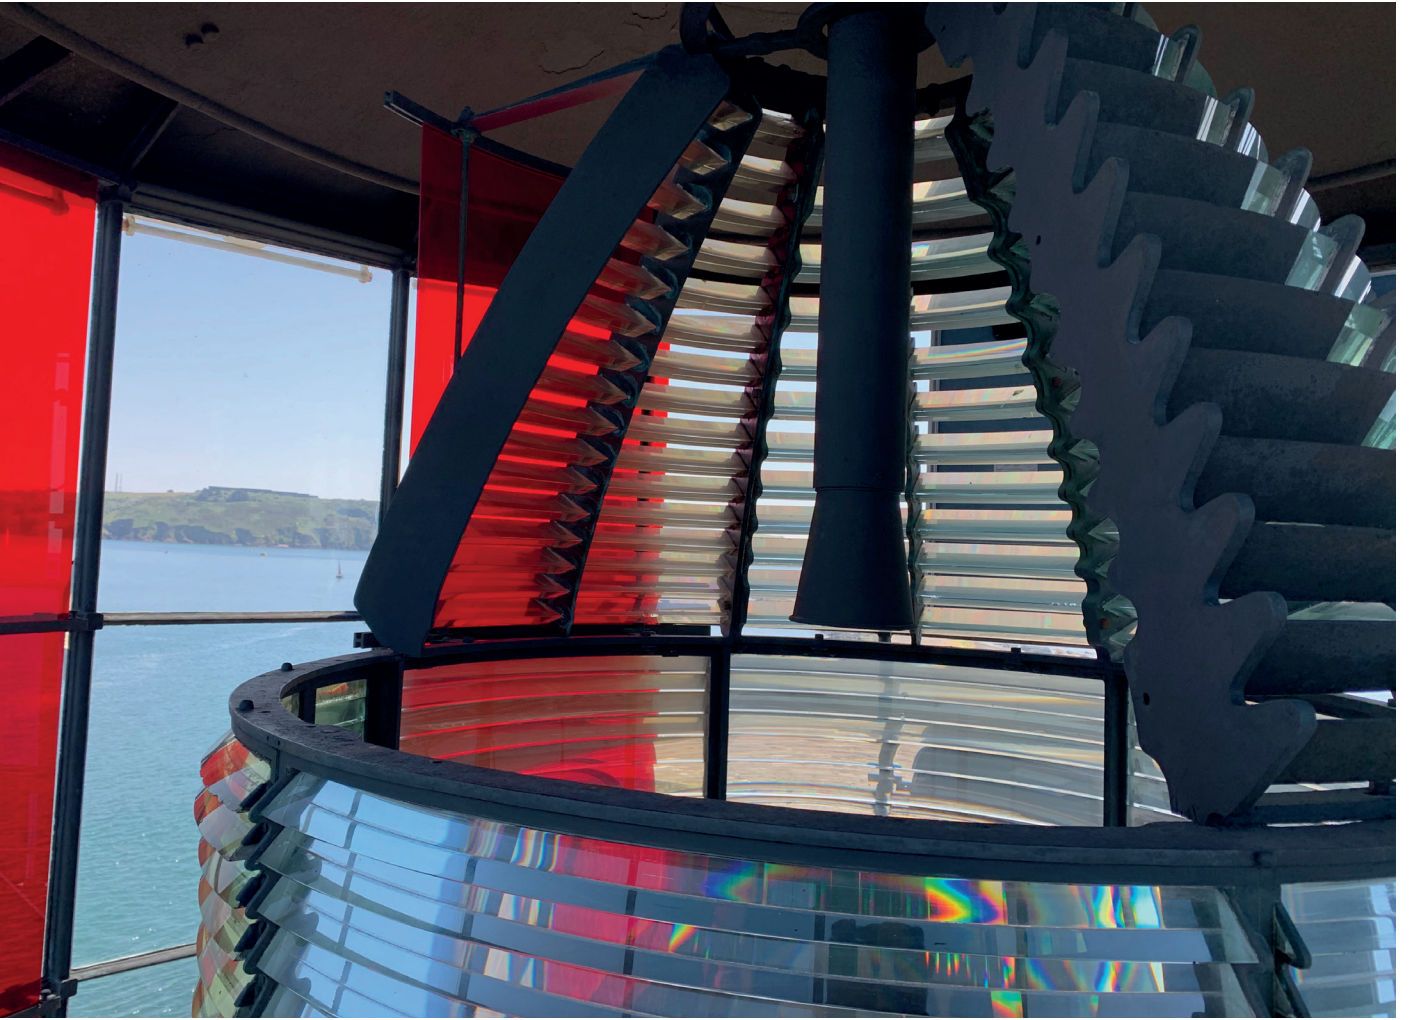
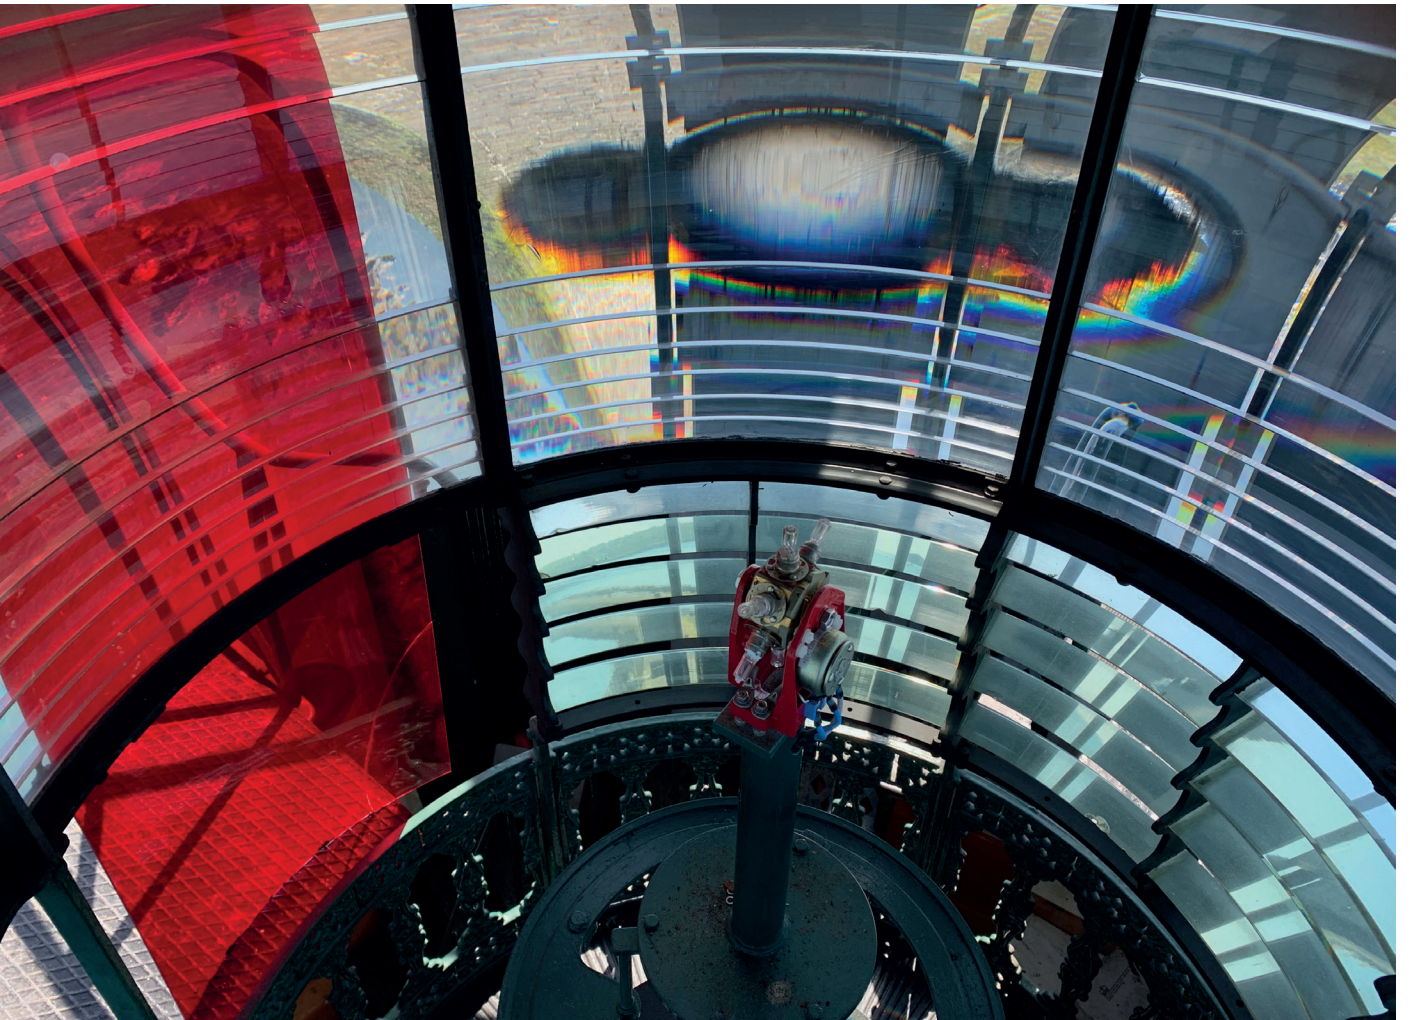
Views of the original optical apparatus. Unlike the situation in some other lighthouses, there are no rotating parts of the light mechanism. The optic remains in a fixed position and the light is switched on and off by electronic control.

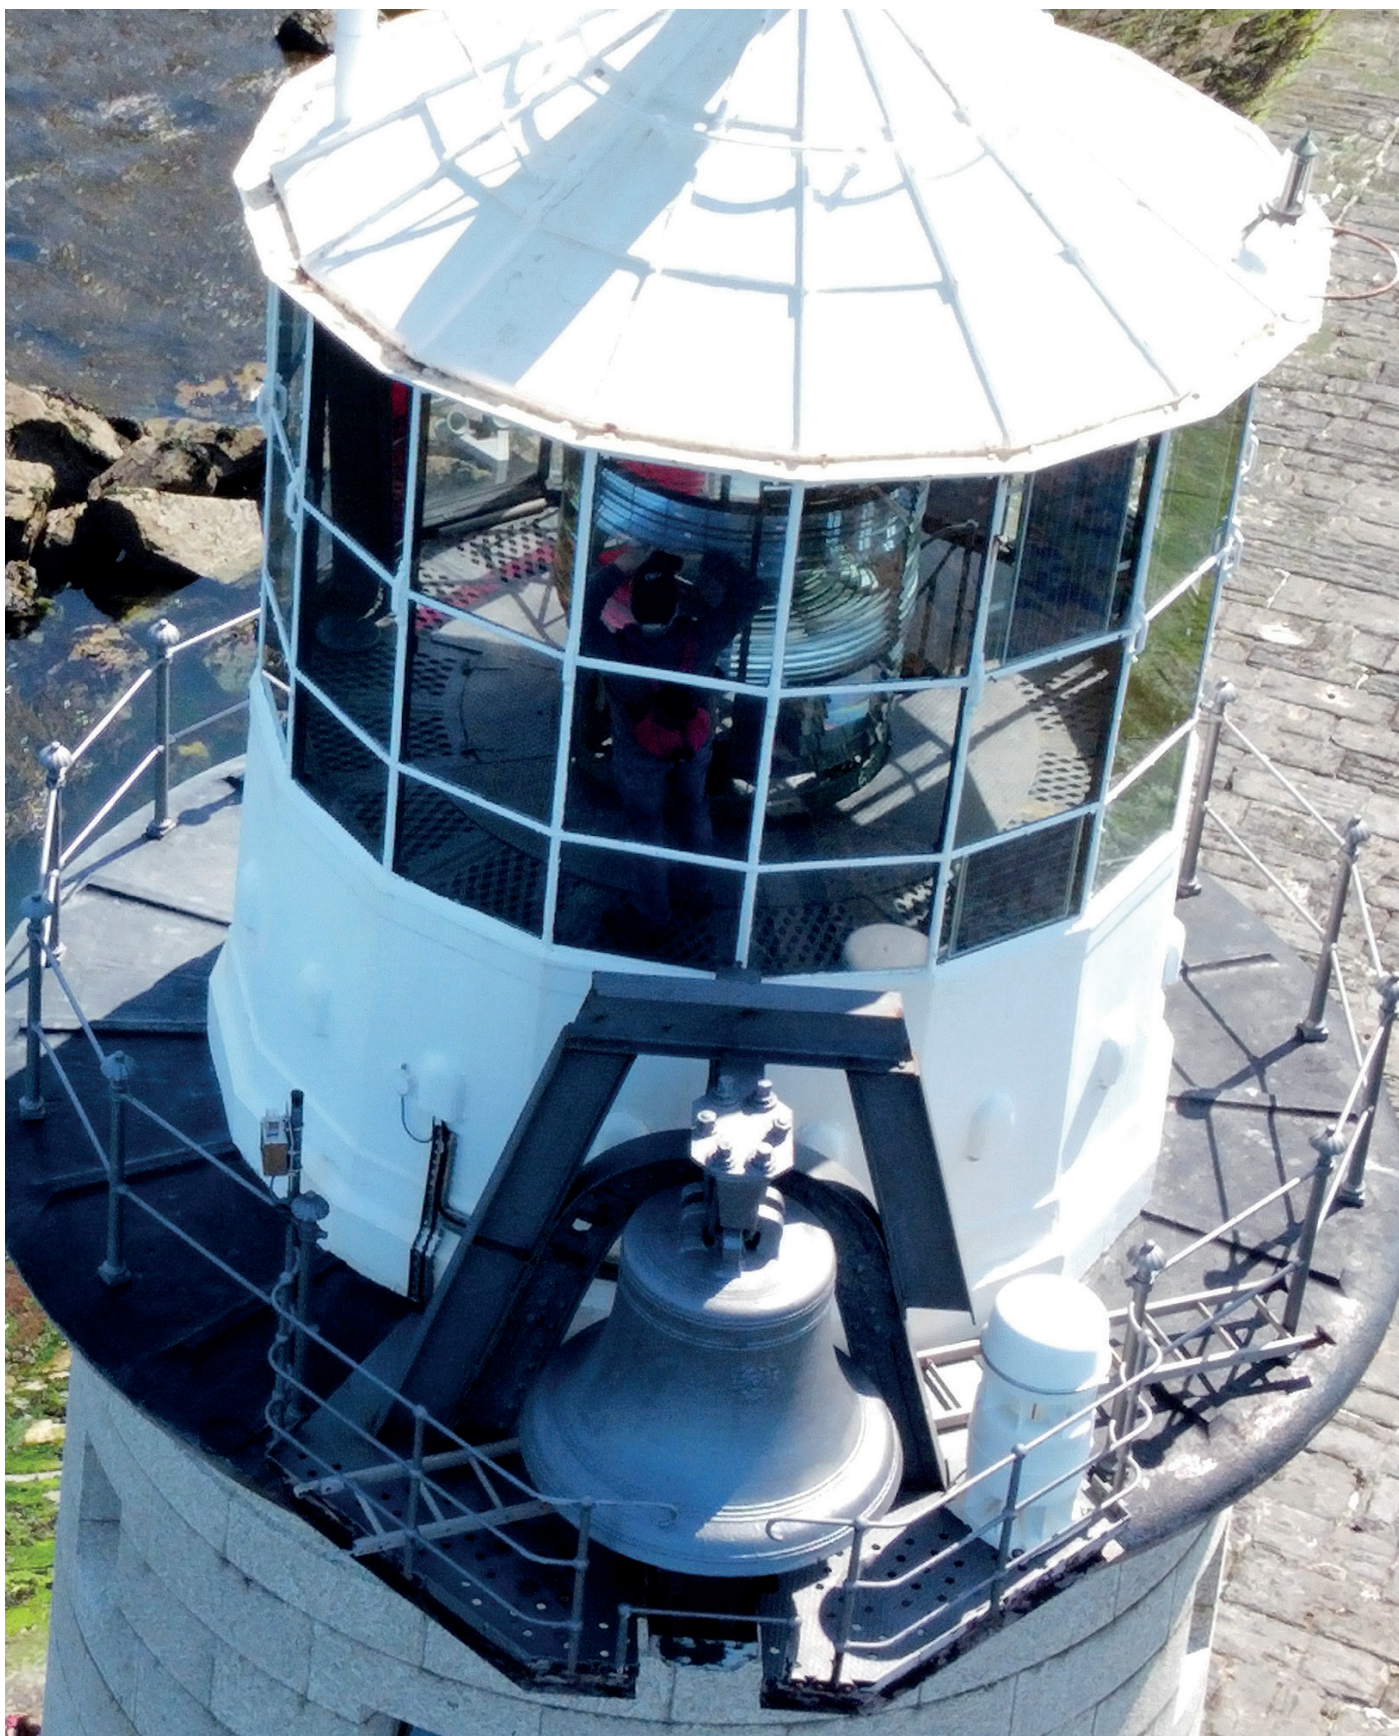
Above: This photo perfectly shows the old fog bell that was in use until 1994, when it was replaced by the modern white unit on the balcony in the lower right corner of the photo. [Photo: Nick Tadd]

One sad point was that we could not exit onto the balcony to see the beautiful old fog bell. Neither was it visible from inside. The bell remained in use until 1994, when it was replaced by an electronic fog horn. Fortunately, one of our group had brought a drone and this enabled some photography of the bell from outside.

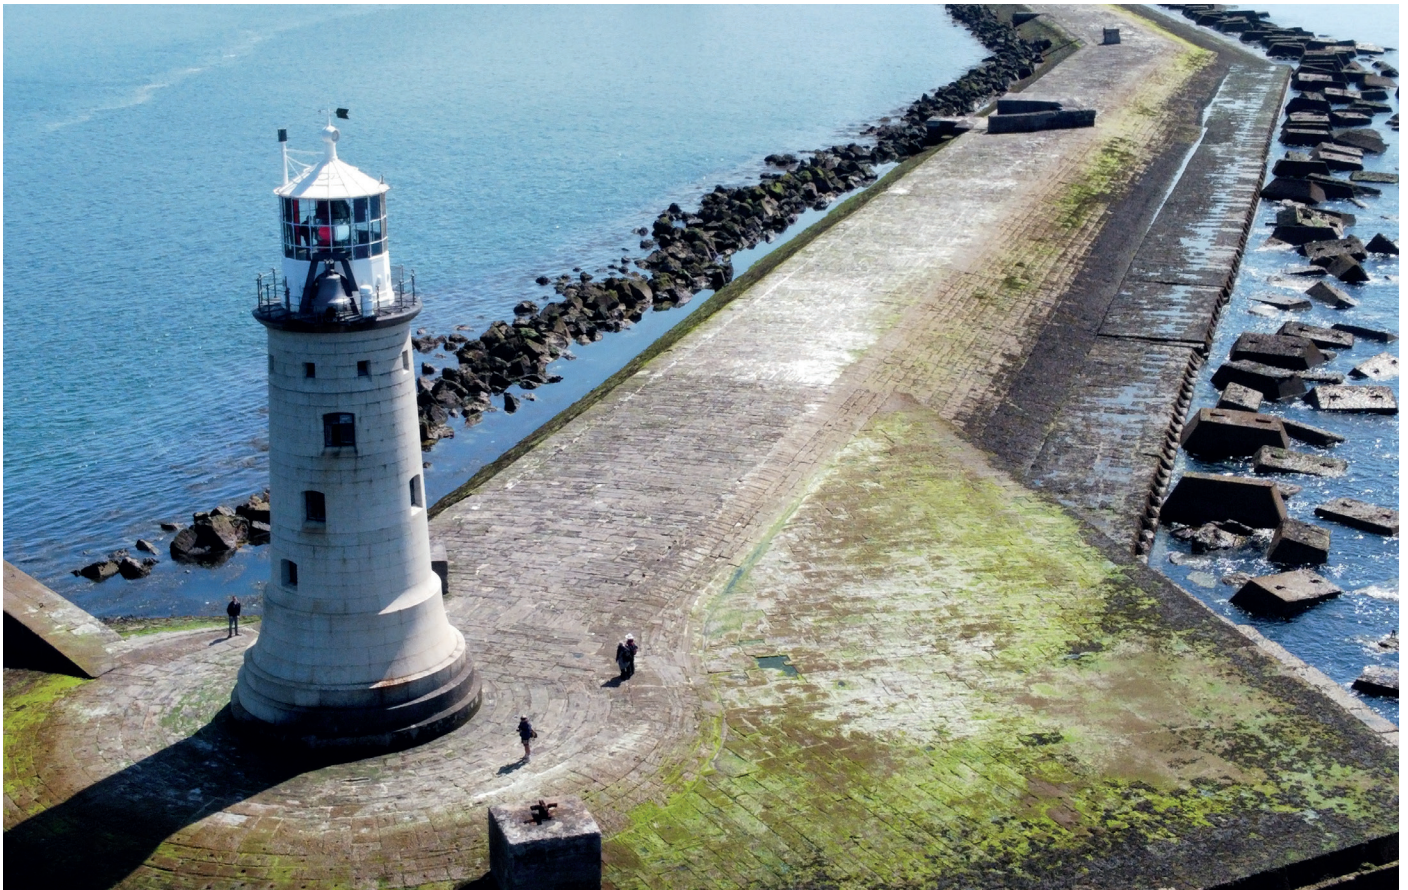
Below: The lighthouse from the air showing the wide apron at the front of the tower. [Photo: Nick Tadd]

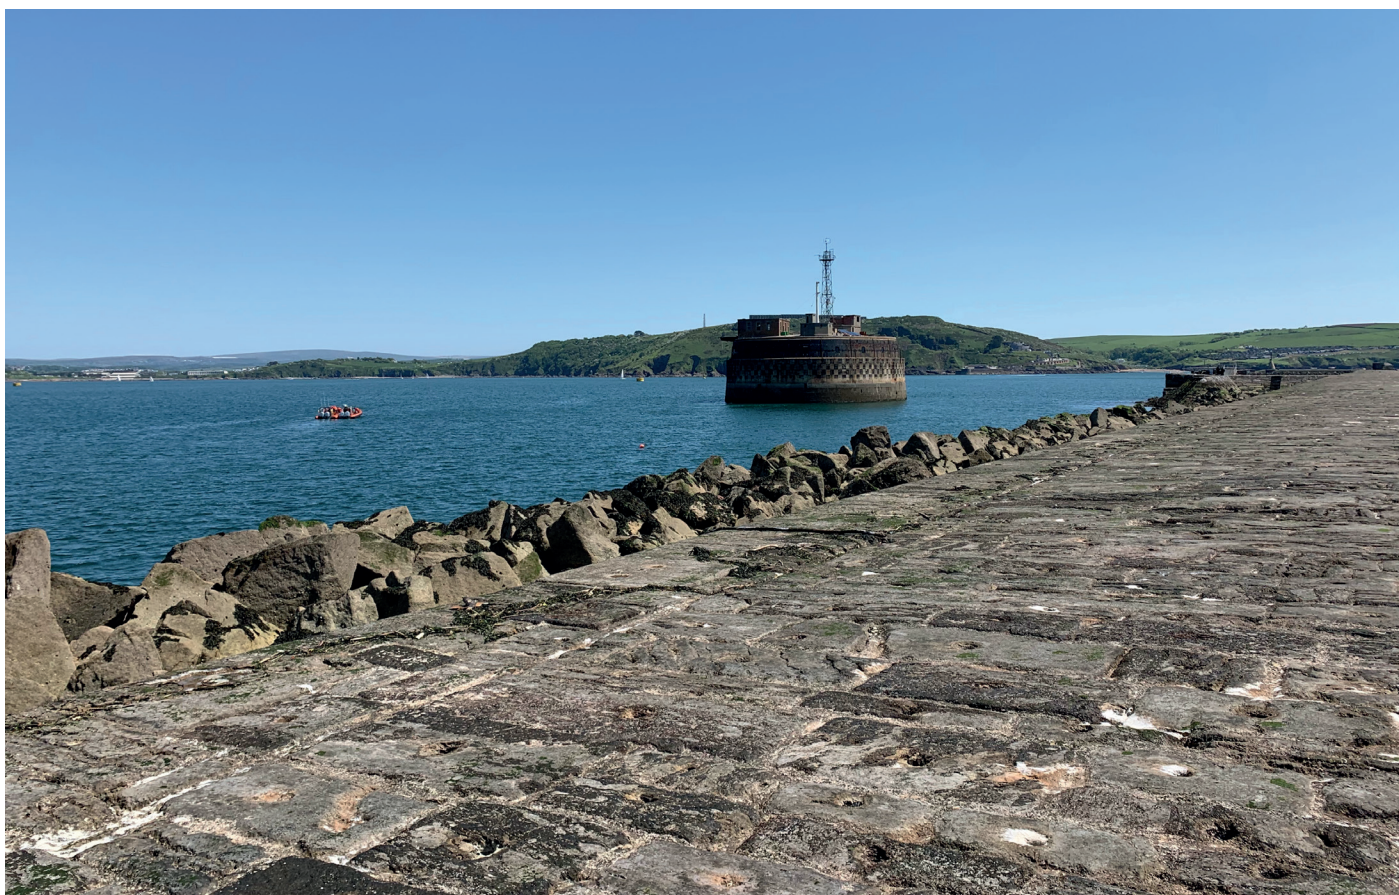
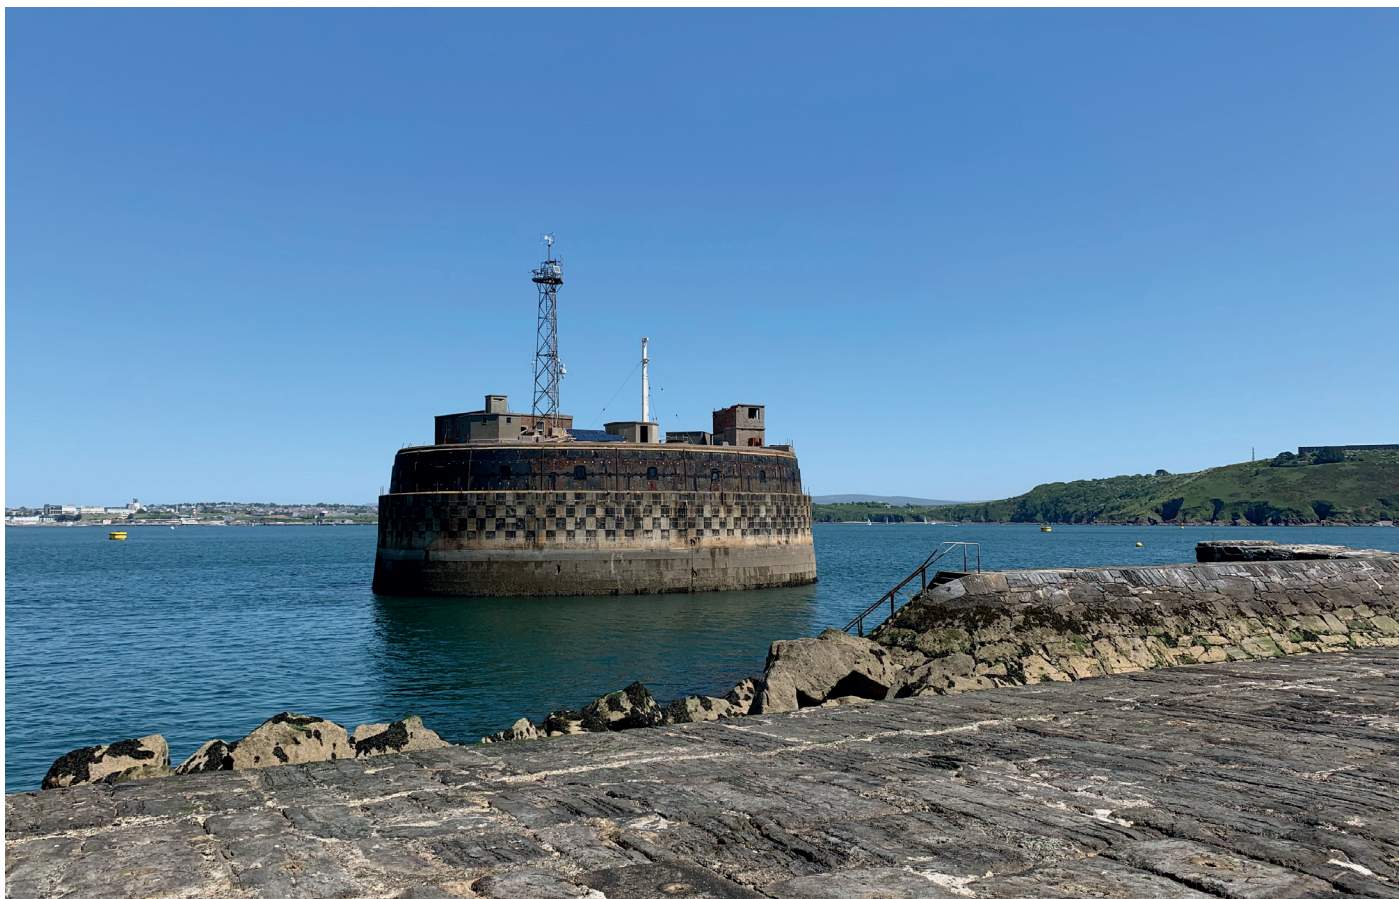
Above: The Breakwater Fort, built in 1860.

Below: A head-on photo of the fort. The distance of the fort from the stones of the Breakwater is 50 m.

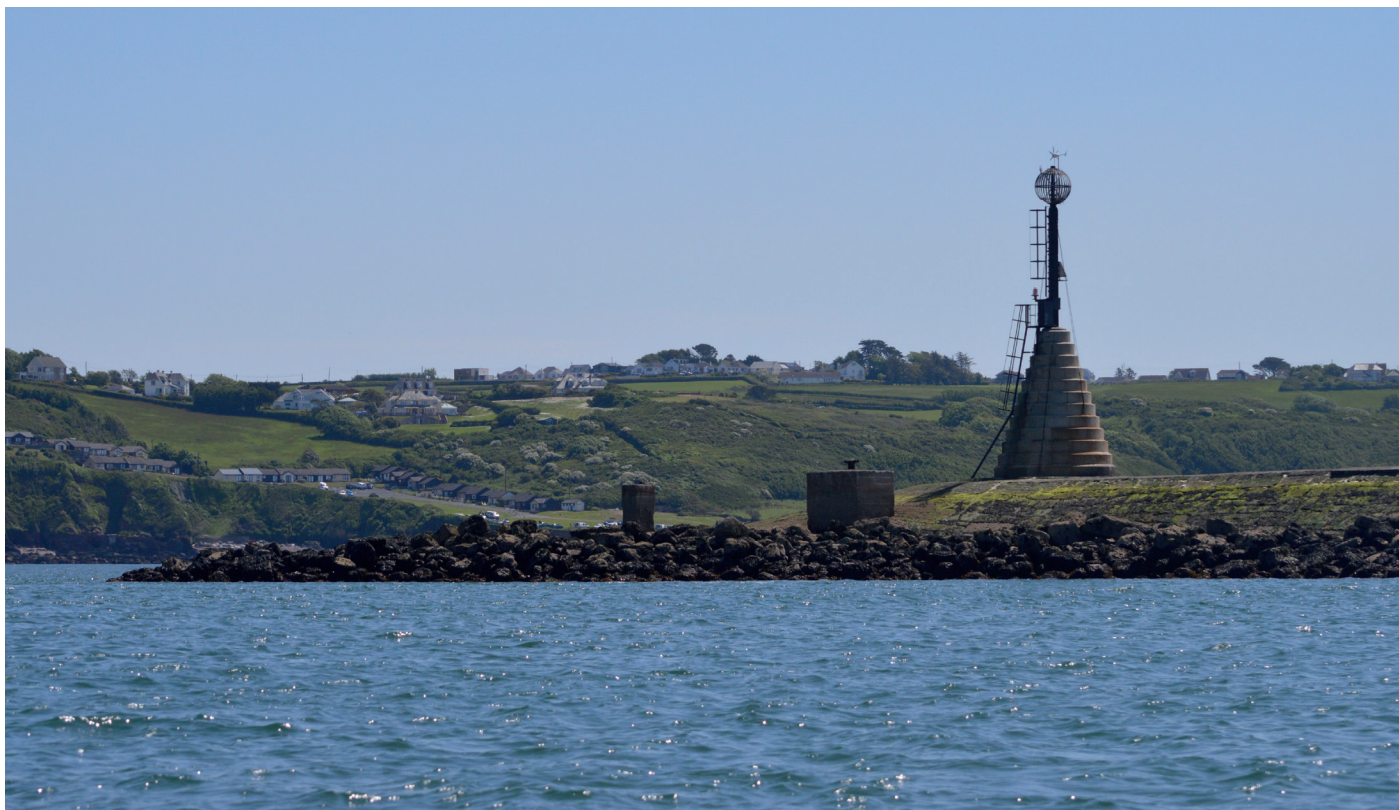
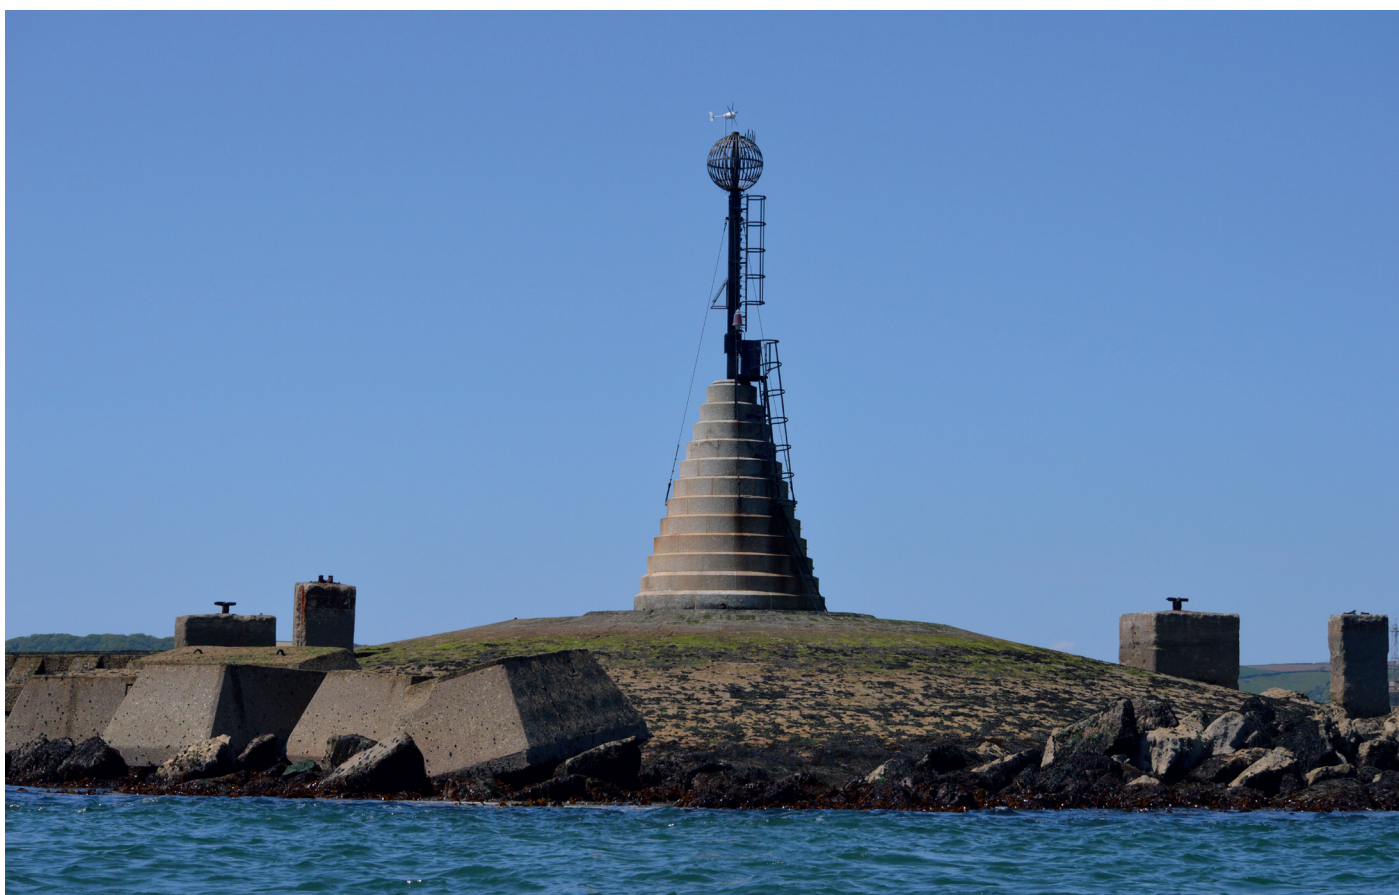
*Above: As we depart, we head around the eastern end of the Breakwater. Houses of Heybrook Bay are in the distance.
Below: The eastern end is the site of a refuge for shipwrecked seamen who climb into the iron ball until rescue arrives.*

On leaving the Breakwater, we circumnavigated the east end where there is an iron ball refuge for ship-wrecked sailors. Then we headed out to the Eddystone in excellent sea conditions, a distance of 19 km (12 mi) that took about 40 minutes on our superbly powerful twelve-seater ribs.
